GEOLOGICAL SOCIETY OF NEW ZEALAND & NEW ZEALAND  
GEOPHYSICAL SOCIETY JOINT ANNUAL CONFERENCE  
TAURANGA 2007

**FIELDTRIP 3**

**AN INTRODUCTION TO SUNNY MATATA  
AND ITS GREAT DEBRIS FLOWS**

## **THE 18 MAY 2005 DEBRIS-FLOW DISASTER AT MATATA: CAUSES AND MITIGATION SUGGESTIONS**

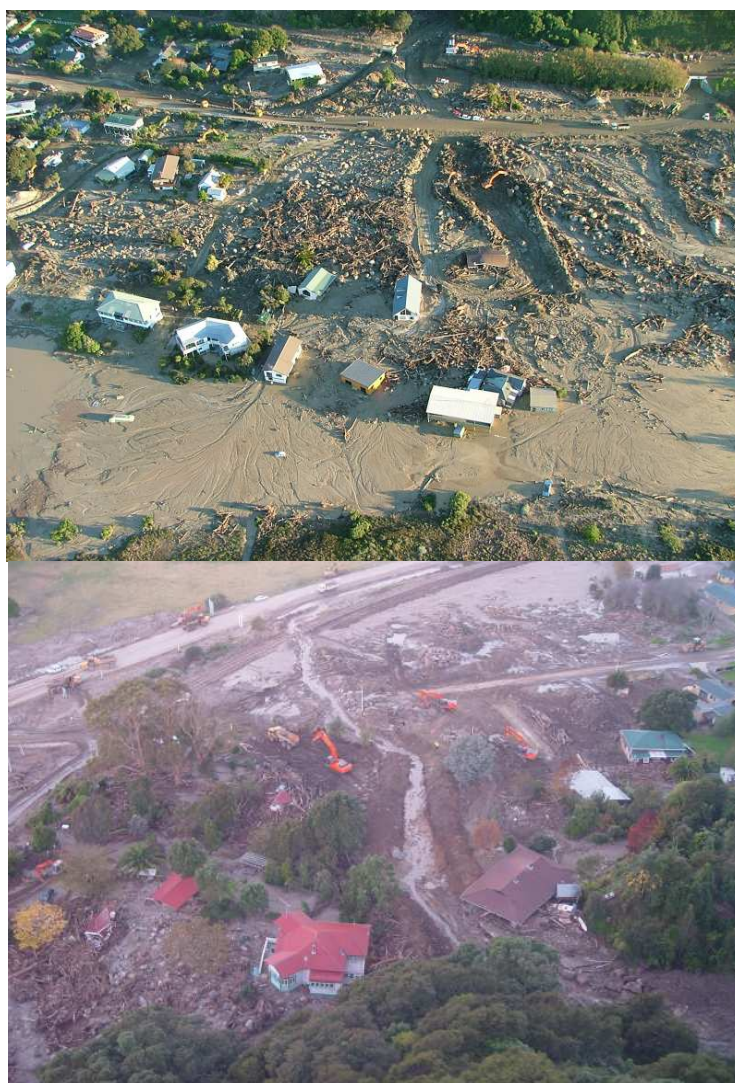
The 18 May 2005 debris-flow disaster at Matata. *Debris flow* damage at Awatarariki (top) and Waitepuru Streams (base).

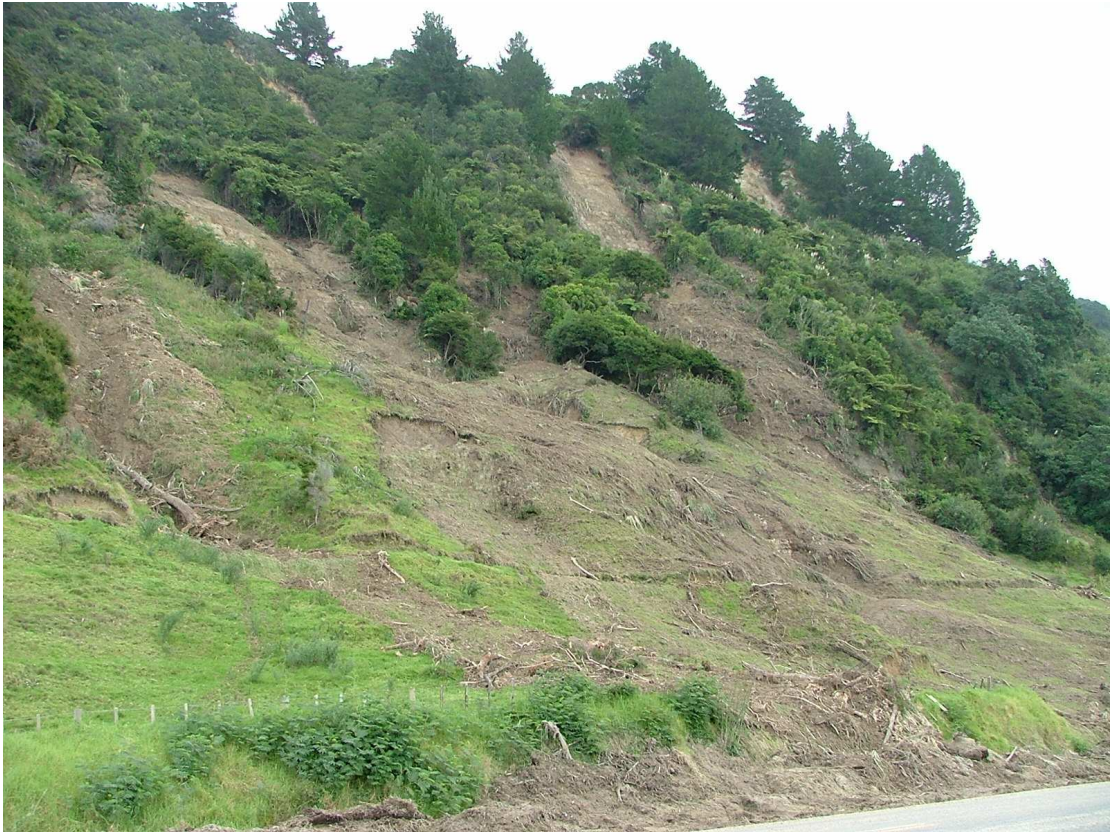
*Debris avalanches* from the old sea cliffs just north of Matata.

- The landslide phenomena that came directly from the hillside above Matata, and along SH2 to the west of Matata were debris avalanches. These are very similar to debris flows, but they lack a confining channel. Similar features falling into the catchments south of Matata initiated the debris flows.

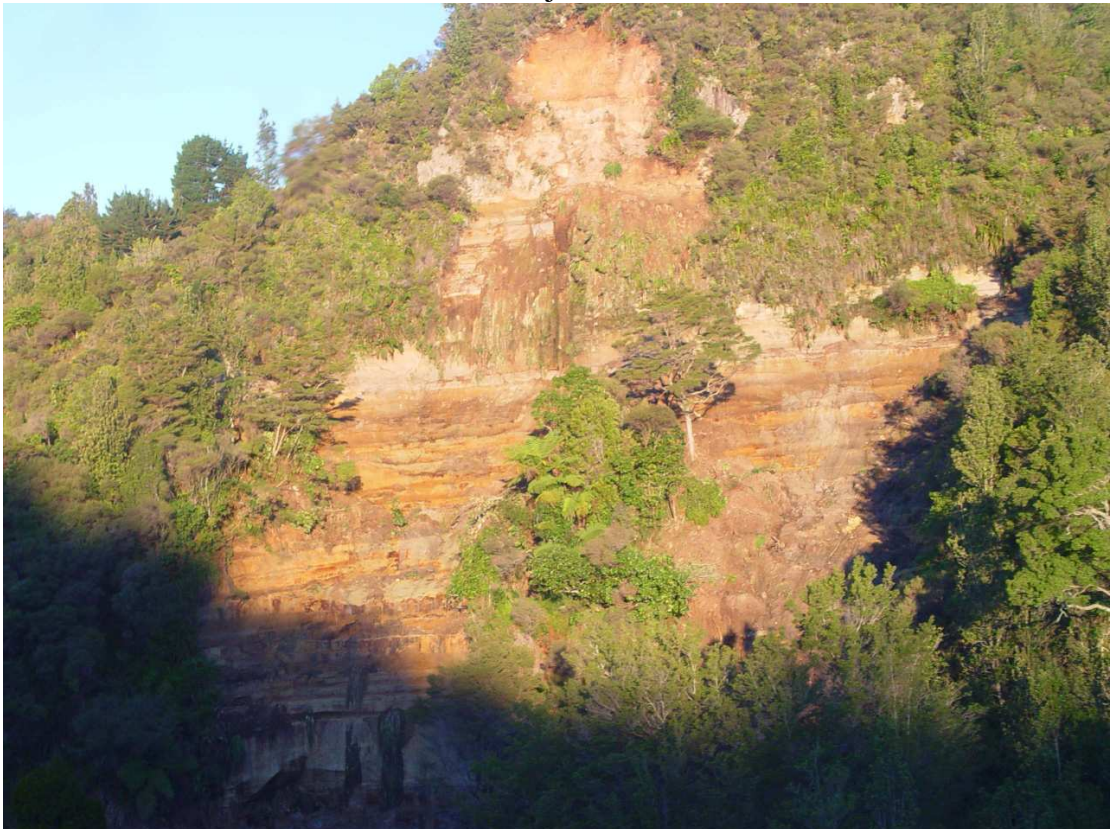
Numerous *debris avalanches* in the upper Awatarariki Stream coalesced to form the *debris flow*.

- Witness descriptions and the physical evidence indicate that the phenomena that damaged Matata in the vicinity of Awatarariki and Waitepuru Streams were debris flows. Evidence in the upper catchments indicates that the debris flows were direct consequences of landslips triggered by exceptionally heavy rain. These debris flows directly damaged some homes and property. Other homes and property were damaged by debris floods that extended beyond where the debris flows came to rest. A debris flow, beyond its limits of flow, is often accompanied by a debris flood. The associated debris flood is regarded by technical experts as an integral part of the total debris-flow event. Debris flows are dense fluid mixtures of all manner of debris and water. They move very rapidly, and are capable of carrying immense boulders. Boulders up to 7 m in diameter were moved by the debris flow in Awatarariki Stream.

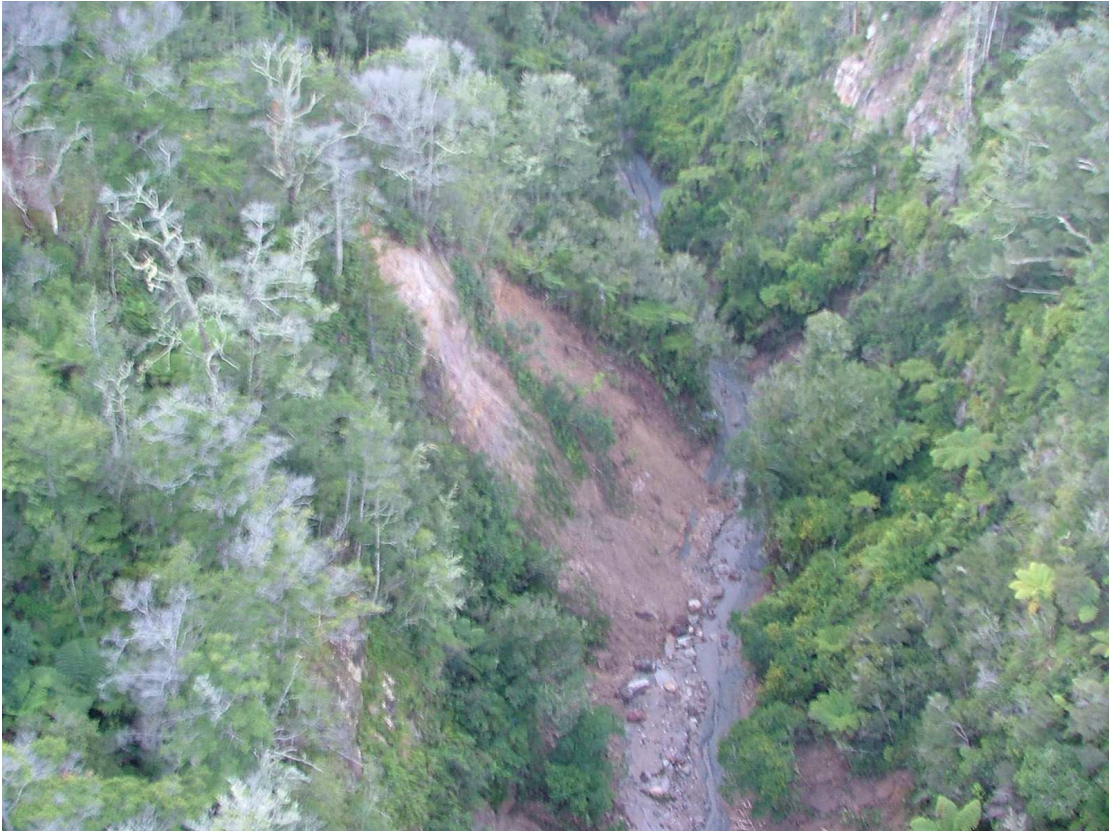
Examples of *debris avalanches* into the Awatarariki Stream behind Matata.

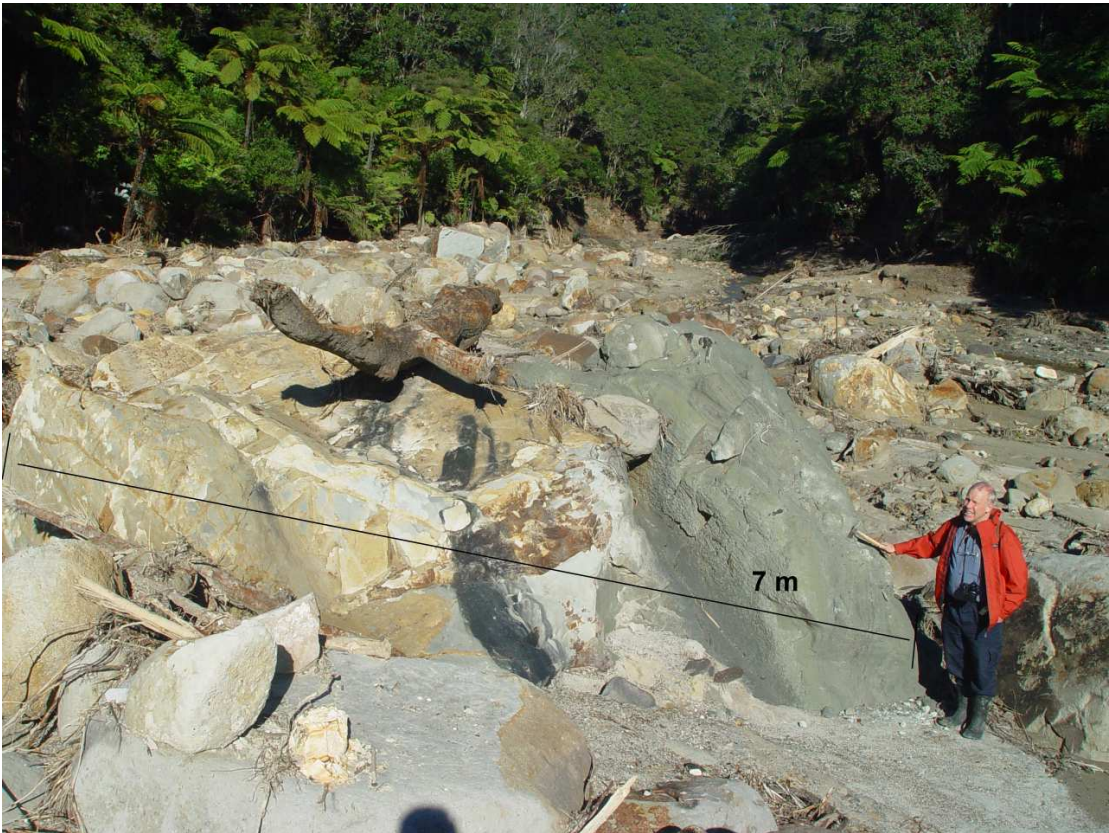
The largest boulder seen that was carried by the *debris flow* in the Awatarariki Stream is about 7m across.

- The boulders carried by the debris flows came mostly from debris-flow erosion of pre-existing boulders previously buried in the bed and banks of the stream channels. They got there by falling from the bluffs above the stream at various times in the past. Most of the harder boulders are derived from strongly welded portions of the Matahina ignimbrite formation. The boulders eroded from the channels already are being replaced by collapse of the steep slopes. This process will continue. Although the supplies of boulders in the channels have been depleted by the event of 18 May, they have not been exhausted. Further debris flows are possible and likely whenever there is rain with high enough intensity to trigger debris avalanches on the steep slopes.

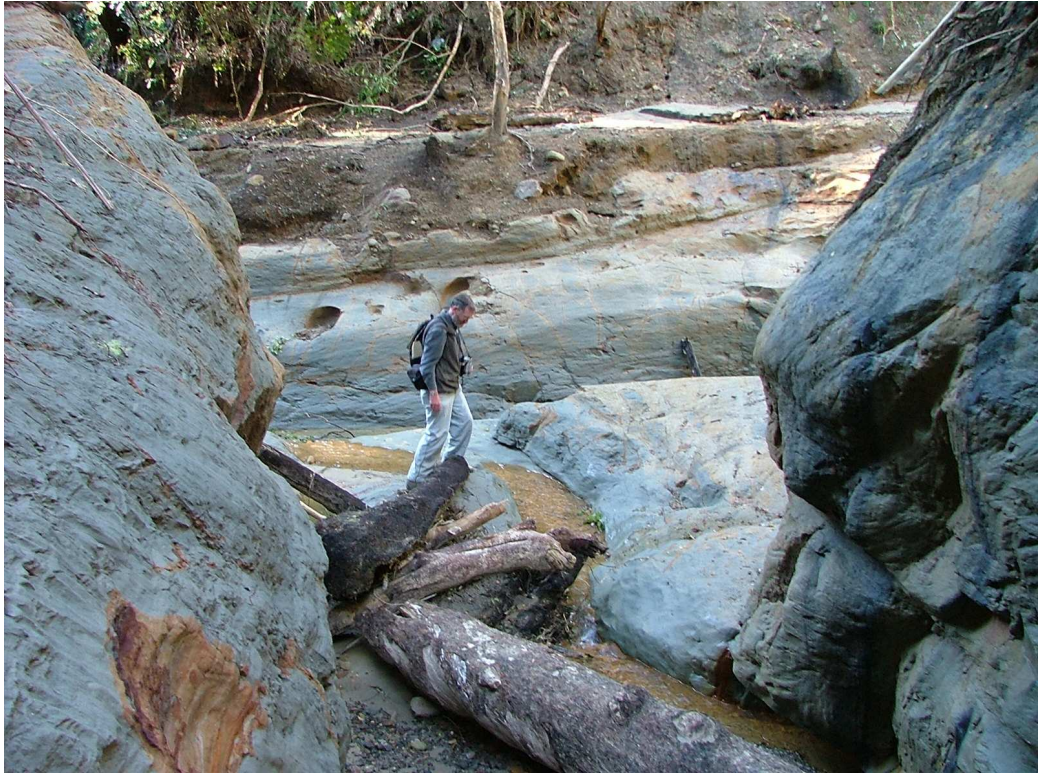
The main stream and a tributary of the Awatarariki, both cleaned out by the erosive power of the *debris flows* that passed down them.

- The evidence that still can be seen as debris dams in the catchments, is from landslides that fell after the debris flows had passed. The highly erosive debris flows cleaned out the valley bottoms, and destabilised the slopes along the channel, causing secondary landslides. Many of these have been larger than many of the initial landslips that triggered the debris flows.
