Annual Conference
Oamaru, NZ

FIELD TRIP 6

AVIEMORE – A DAM OF TWO HALVES

AVIEMORE - A DAM OF TWO HALVES

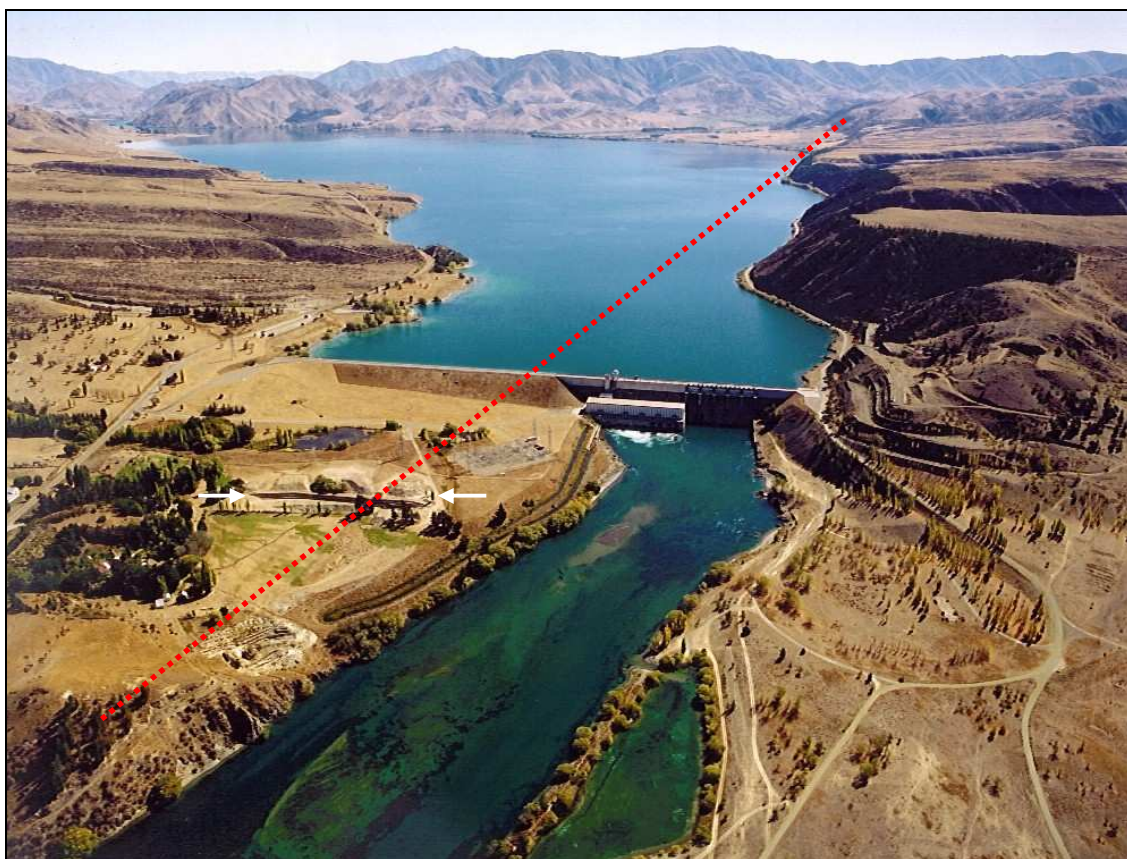
Figure 3: Aerial view NW across Aviemore Power Station. The powerhouse lies in front of the concrete gravity dam, with the grass-covered embankment dam to the left. Downstream of the dam are remnants of the ‘Aviemore’ alluvial terrace, with terraced alluvial fans to the far left. Note the approximate position of the Waitangi Fault (red line) and the large ‘Pinetrees’ (T01/1) fault investigation trench (white arrows). Photo: D.L. Homer, GNS Science.

The dam straddles the Waitangi Fault, and its design reflected the differing foundation conditions on either side of the north-south (upstream-downstream) trending fault. The concrete gravity dam across the former channel of the Waitaki River is founded on unweathered to slightly weathered, 'hard', closely jointed, Mesozoic-age, interbedded sandstones and mudstones (greywacke). The earthfill embankment on the western side of the valley ('true' right, i.e. looking downstream) has a core mainly founded on lower quality, 'soft', unweathered, Tertiary claystones, sandstones and coal, with shoulders largely founded on coarse-grained alluvial deposits. The Waitangi Fault crosses the embankment foundations approximately 30 m from the west (true right) end of the concrete dam so that greywacke, including some sheared mudstone, is also present in part of the embankment foundations.

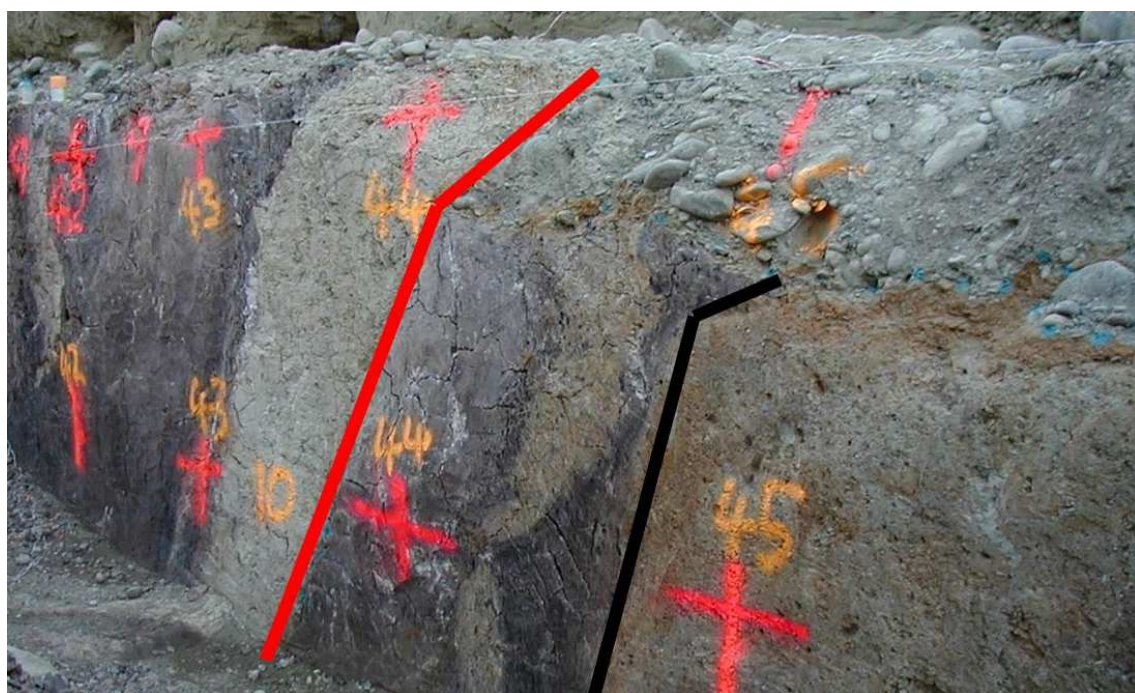
Figure 5: Exposures in trench T00/3, looking south. **Upper:** Beyond the Waitangi bedrock fault (black line) are two late Quaternary faults, Fault 1 (nearer red line) and Fault 2 (far red line). **Lower:** Close-up of the bedrock fault (black line, right) and Fault 1 (red line, left), which has a vertical separation of 0.5 m, defined by Tertiary clay up to the left against Aviemore alluvial deposits.

There was a reasonable consistency between trenches on the total amount of vertical bedrock strath offset, independent of the number of events recognized. The best information for single-event displacement measurements came from T00/3 where Fault 1 and Fault 2 broke through on separate slip surfaces, as well as terminating vertically against different alluvial deposits (Figures 5 to 7). The rupture on Fault 1 is older than that on Fault 2, and does not appear to have involved rupture of Fault 2.

Fault 1 (penultimate surface rupture) has a vertical separation of 0.5 m on the base of the Aviemore alluvial deposits (bedrock strath), and slickenside lineations indicated a horizontal to vertical slip ratio of about 1H:3V (i.e. 0.1–0.2 m horizontal component). Combining these data on a steeply dipping fault plane ($\geq 70^\circ$) indicates a net surface-rupture displacement of approximately 0.6 m.

Fault 2 (the most recent surface rupture event) has a vertical separation at the fault plane is at least 1.0 m, but if warping over a zone up to 5 m west of the fault plane is taken into account, the vertical separation could be as much as 2.0 m. Measured slickenside lineations indicated a horizontal to vertical ratio in the order of 1H:2V and 1H:3V (i.e. 0.3 to 1.0 m horizontal component) indicating a net surface rupture displacement of at least 1.1 m (1.0 m vertical; 1H:3V) and possibly as much as 2.4 m (2.0 m vertical; 1H:2V) on a steeply dipping ($\geq 70^\circ$) fault plane.

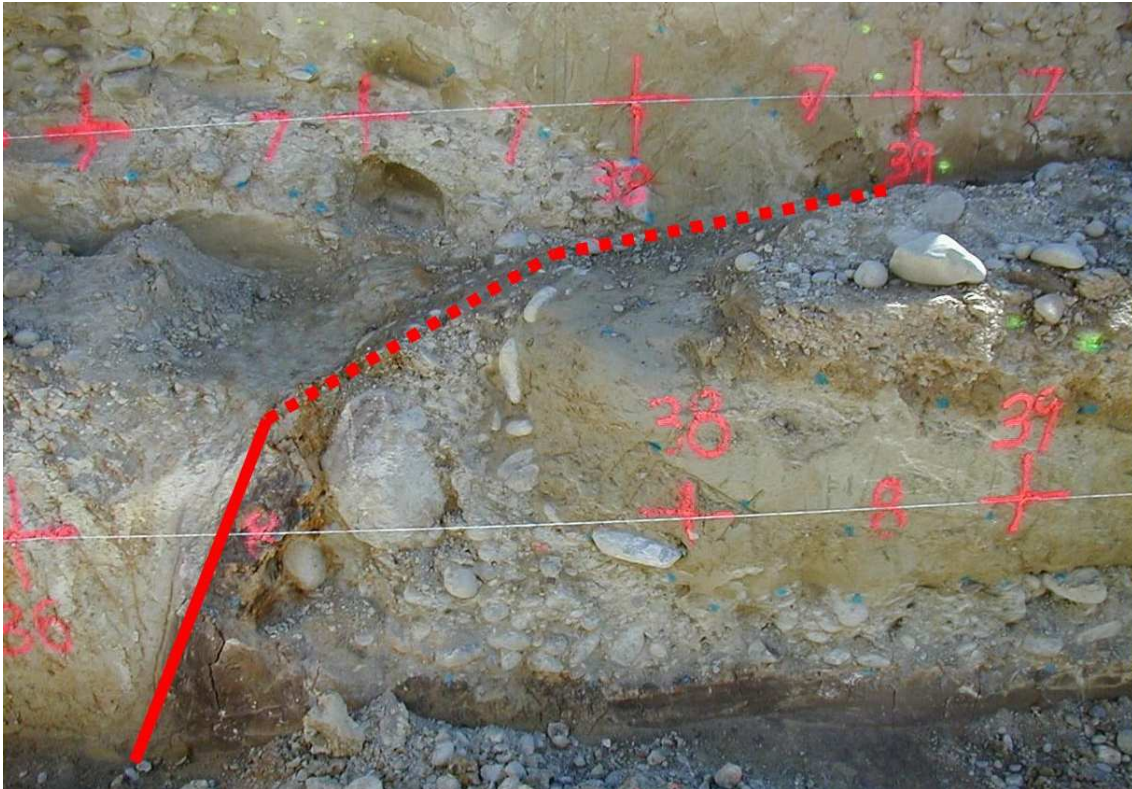
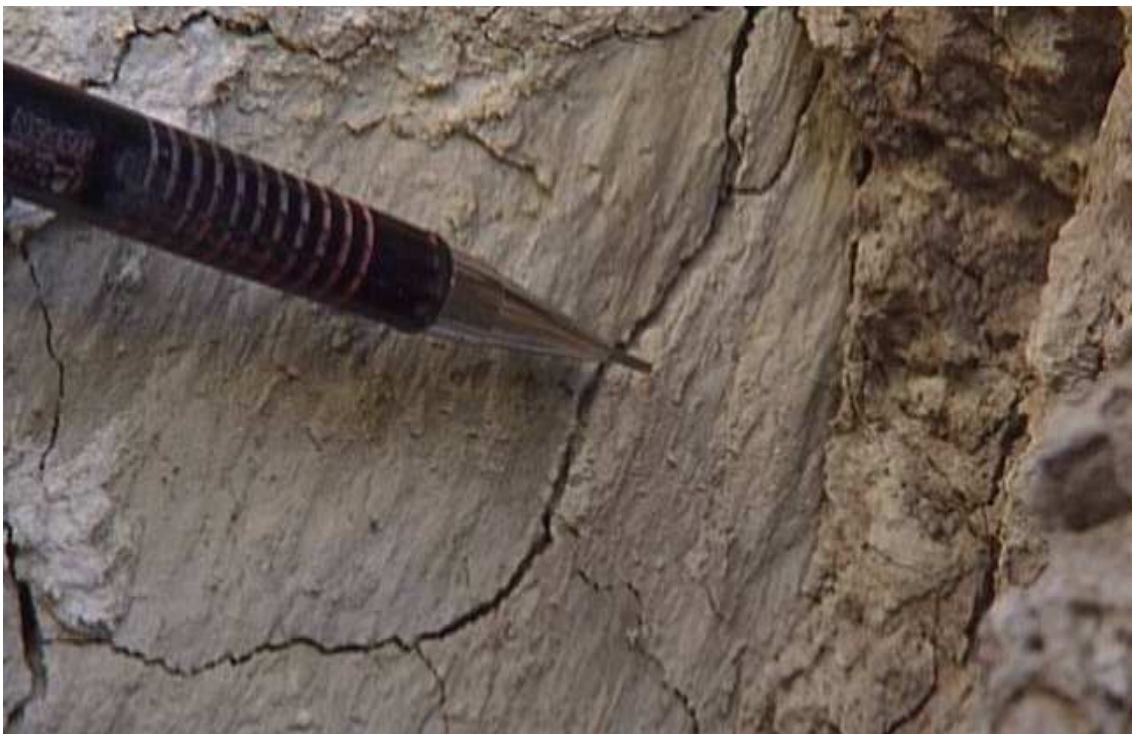
Figure 6: Detail of exposures in trench T00/3. **Upper:** Close-up of Fault 2, with at-fault vertical separation of at least 1.0 m. The fault displacement extends higher into the stratigraphic sequence than does Fault 1, and thus represents a separate, younger, rupture event. **Lower:** The pencil is perpendicular to steeply-pitching slickenside lineations on Fault 2. The lineations indicate oblique reverse-right lateral slip.

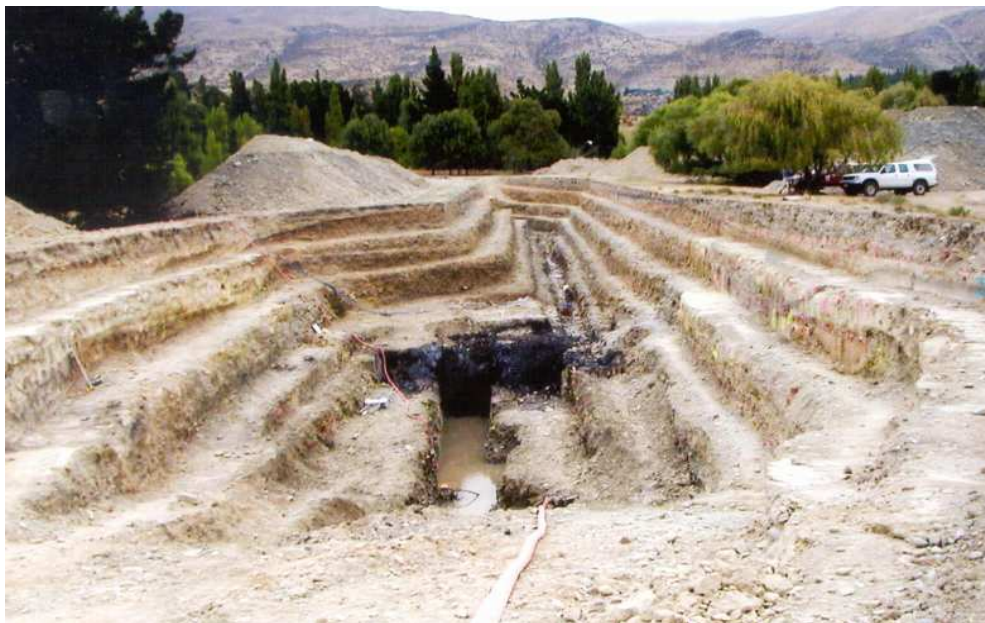
Figure 8: The benched, up to 10 m deep, trench T01/1 ('Pinetrees') excavation, looking southwest. The black material is coal on the upthrown (SW) side of the Waitangi Fault.

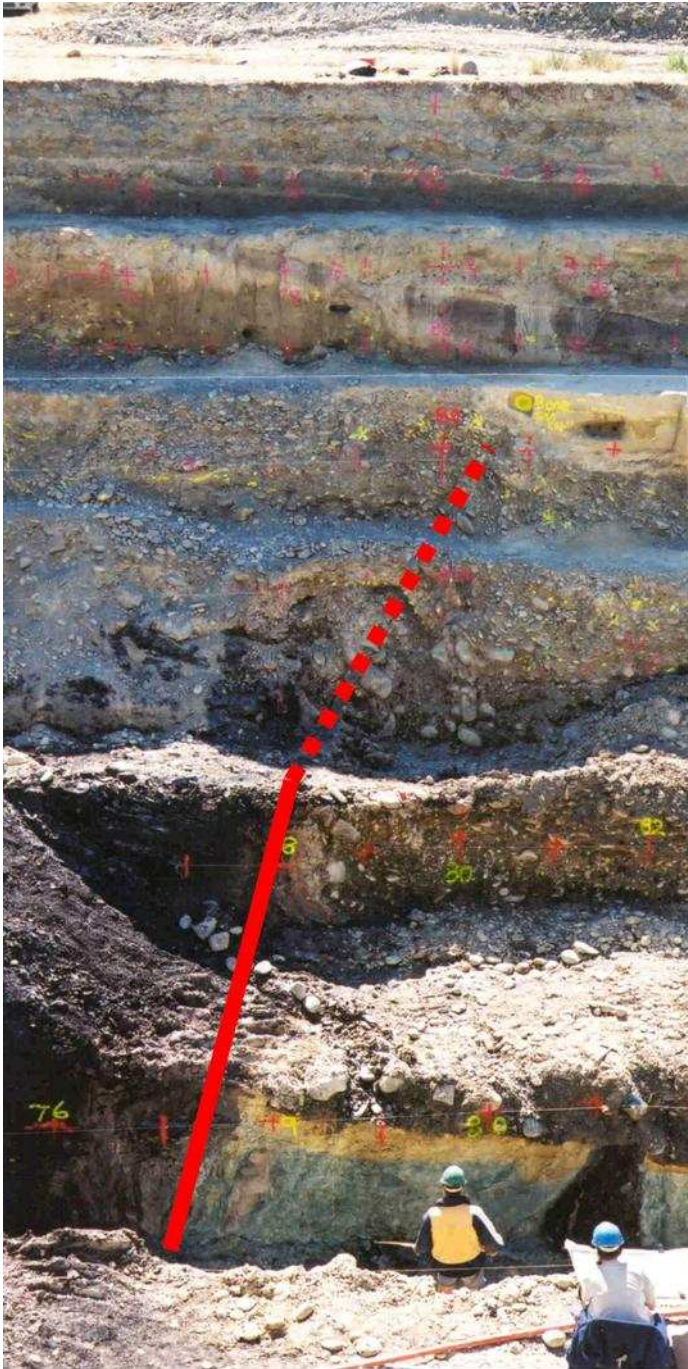
Figure 9: Trench T01/1, looking northwest across the deepest (~10 m) part of the excavation. A Tertiary coal seam (bottom left) has been displaced upwards against subvertical green and dark brown Tertiary clays (weathered yellow directly under the strath) and into the overlying Waitaki River gravel (Aviemore alluvial deposits). Evidence for at least two successive fault displacements is preserved within the stratigraphy of this exposure. The dashed red line denotes more diffused deformation.

In other trenches, the most recent ruptures broke through on a single slip surface, and the sizes of individual single-event displacements were difficult to quantify. In T01/1 contrasts in gravel thicknesses provided a possible indication of a third (probably small) fault rupture during deposition of the Aviemore alluvial deposits. However, in high-energy river environments such as the Waitaki valley, coarse-grained alluvial deposits are commonly associated with irregularly eroded bedrock straths, which reduces the opportunities for confident detection of individual smaller events.

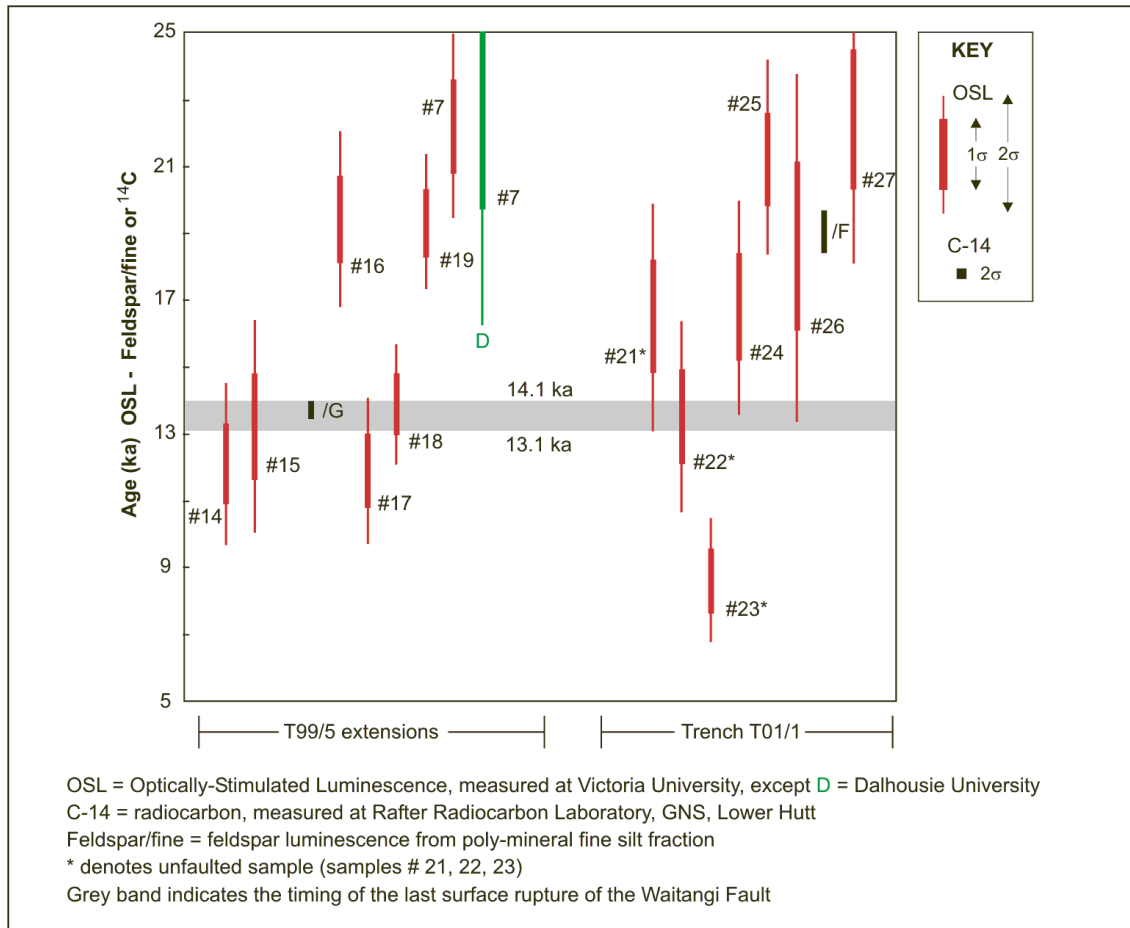
Figure 12: Luminescence and radiocarbon dating results for trench T99/5 (and its extensions, T00/1 – T00/3) and trench T01/1.

Of these OSL and radiocarbon dating results for samples from the Waitangi Fault trenches, eight of the dates help to constrain the time since the last fault rupture. Five samples came from materials offset by faulting, while three samples came from materials not offset and therefore younger than the last fault rupture (Figure 12). The preferred estimate of 13.1 to 14.1 ka (1 ka = 1000 years before present) is defined by the interval between the older error limits of the youngest faulted samples (#17 and /G) and the younger error limits of the oldest unfaulted sample (#21). The older end of the range (14 ka) is relatively well constrained by 3 dates (#17, /G, #14). The constraint on the younger end (13 ka) is more sensitive; the time since last rupture would reduce to 10.7 ka (#22) in the absence of sample #21 (13.1 ka). It was concluded that the fault has not ruptured since 10.7 ka, and probably not since 13.1 ka.

The age of Aviemore alluvial deposits, which contain a record of at least two fault rupture events, is constrained only broadly, largely because of relatively few finer-grained horizons suitable for luminescence dating. Sample #7 (two standard deviation range (2σ) of 19.5 to 25 ka) was from close to the bedrock strath, while sample #25 (2σ range of 18.5 to 24 ka) was from nearer to the middle of the unit. Given that samples #26, #27 and /F, with a mean age of 20.0 ka (2σ range of 13.5 to 26.5 ka) are from near the base of overlying fan alluvium. By about 15 ka, the Waitaki River had incised into the Aviemore alluvial deposits, and locally-derived fan alluvium was being deposited in places on river-cut surfaces (see Figures 10 and 11). The timing of river incision at Aviemore is broadly compatible with the last major advance and subsequent withdrawal of Last Glaciation ice at Lake Pukaki, about 17.5 ka (Schaefer et al. 2006).
