Geosciences 2016

Field Trip 9
2 December 2016

Faults, Landslides, Precarious Rocks and Dam

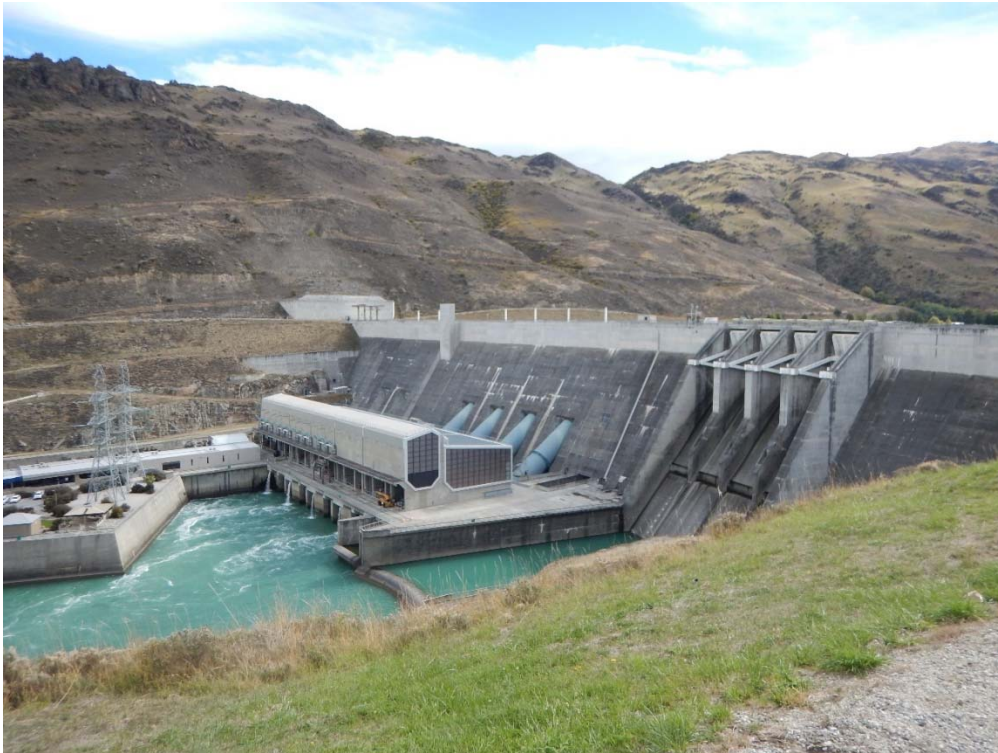
Figure 3: The Clyde Dam (Photograph by Mark Stirling)

The Clyde Dam is the largest concrete dam in New Zealand and provides a significant component of electricity to the national grid (Fig. 3). Completion of the dam project in the early 1990s followed extensive investigations of active faults in the area, and the investigation and stabilisation of landslides in the Cromwell Gorge. The dam sits at the downstream end of the antecedent Cromwell Gorge, and is upstream of the reverse-slip Dunstan Fault. The Dunstan Fault is responsible for uplift of the Dunstan Mountains, and is the most significant contributor to seismic hazard at the dam site.

Courtesy of Contact Energy Ltd we will be taken on a tour of the dam for a period of about one hour. The tour will take in the control room, powerhouse, and the slip joint within the dam. The slip joint was designed to accommodate 1-2 m of slippage on the River Channel Fault, which was discovered during dam foundation excavations. After visiting the dam site we will travel to Clyde to pick up some lunch.

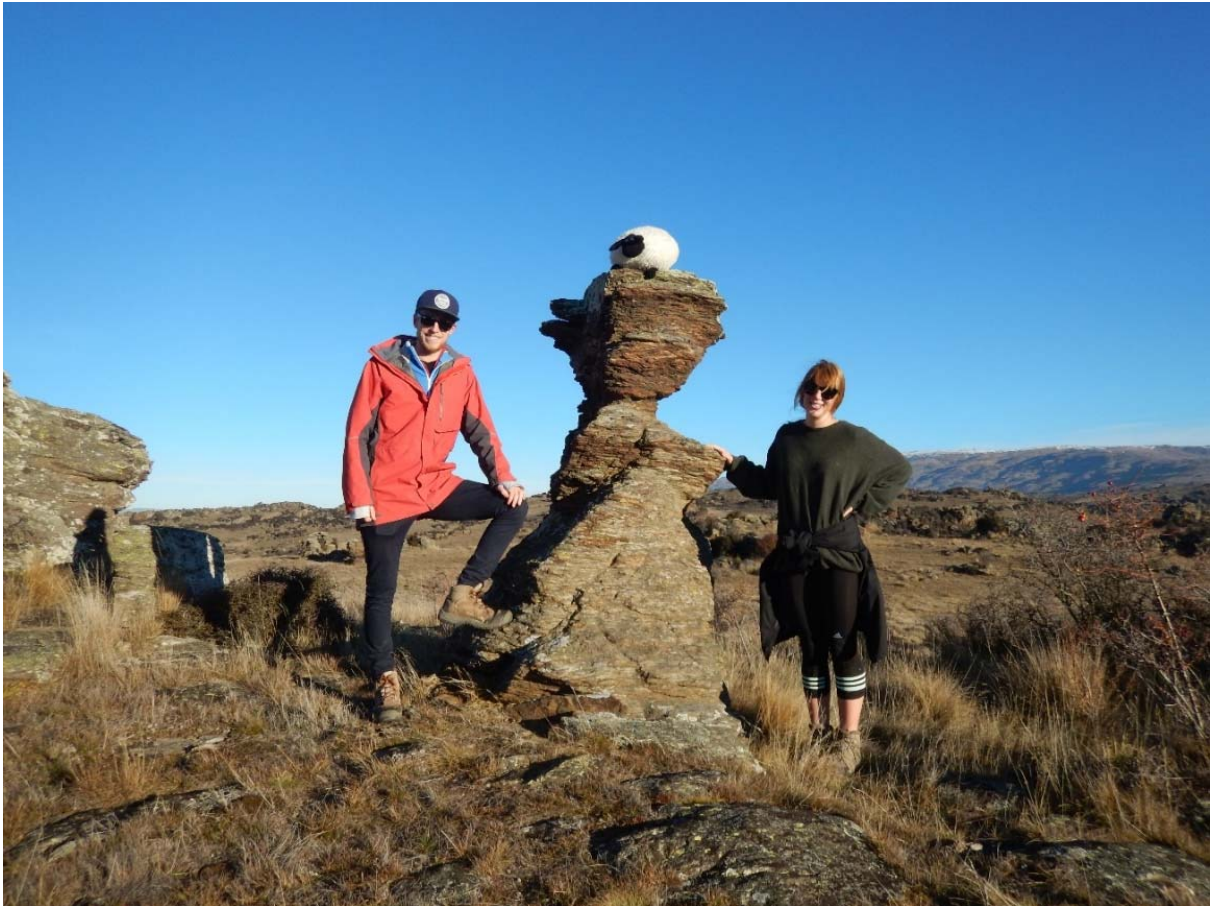
Figure 4: One of the PBRs at Cairnmuir Flat. The narrowest part of the tor marks the boundary between the PBR and pedestal (Photograph by Mark Stirling).

The trip proceeds back across the Clutha River and ascends Hawksburn Road to the Clyde lookout. At the lookout we will look out along the range front of the Dunstan Mountains and see the southwestern-most traces of the Dunstan Fault. The history of investigations on the fault will be briefly described. We will then proceed up to Cairnmuir Flat, a peneplain plateau remnant studded with spectacular schist tors, many with precariously-balanced rocks (PBRs) present (Fig. 4). The road beyond the Clyde lookout is not suitable for road vehicles, so participants will be ferried up to the next stop in a 4WD vehicle if we don't have enough 4WD vehicles to go up all at once. Once on the plateau we will visit at least one of the PBRs. The location of the ancient PBRs close to both the Clyde Dam and Dunstan Fault provides important constraints on near-field ground motions from the fault. An intensive programme of cosmogenic dating of the PBRs, and an assessment of the associated fragilities (ground motions required to topple the PBRs) has been conducted in recent years, and represents a world-first for PBR research being used in a commissioned seismic hazard assessment. The PBR fragility ages (time since the PBRs obtained their present unstable geometries) range from c. 20-70kyrs, which means that they provide significant long-term constraints on local seismic hazard. After seeing the PBRs, we will travel back down Hawksburn Road to Clyde.

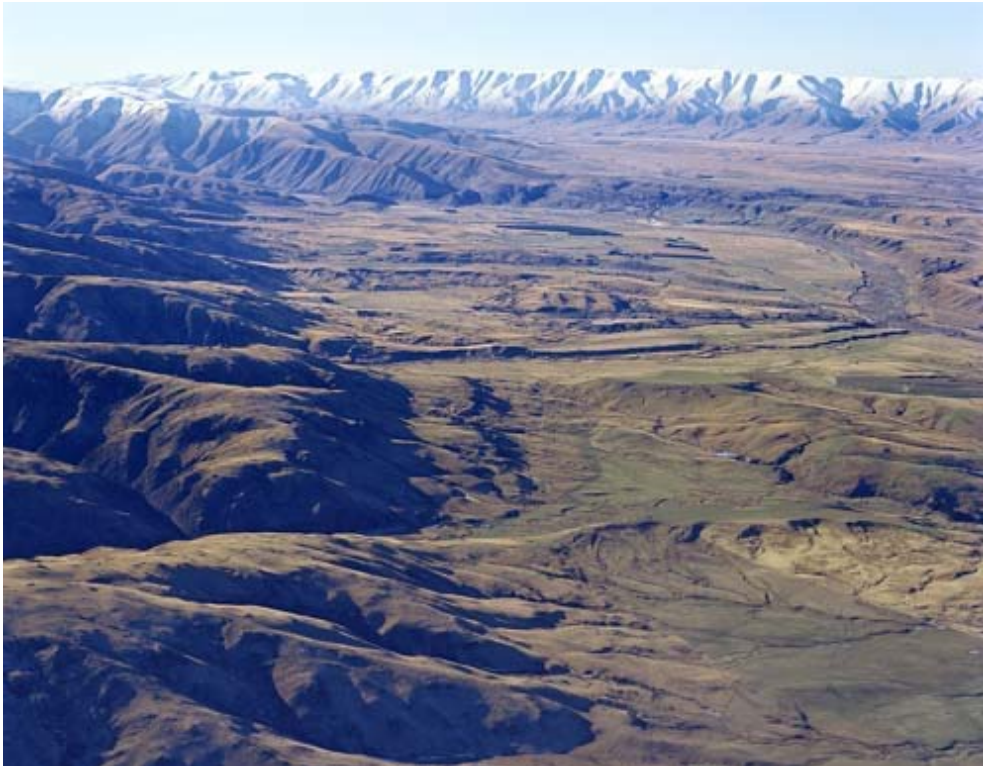
Figure 5: View northeast along the Dunstan Mountains range front and Dunstan Fault. Scarp features are accentuated by the shade lines in the middle of the image (Photograph by Lloyd Homer)

We will travel northeast to the Devonshire area of the central Dunstan Fault. This is where the majority of paleoseismic data have been gathered for the Dunstan Fault during two generations of Clyde Dam seismic hazard assessments (Figs. 5-8). As we approach the Dunstan Mountains range front on Devonshire Road we will cross scarps of the Dunstan Fault. The findings of the paleoseismic work will be discussed at the road end. We will end the day with the drive back to the Lake Wanaka Centre.

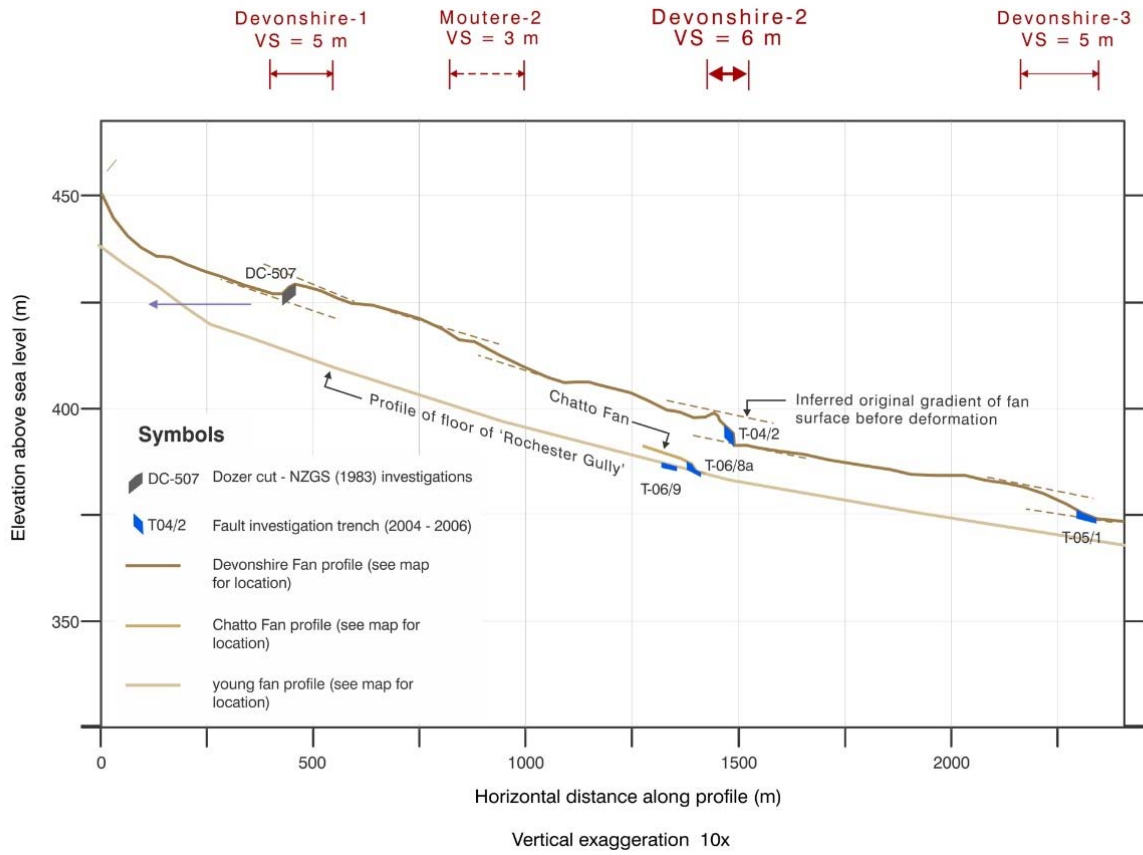
Figure 7: Profile of the Devonshire area

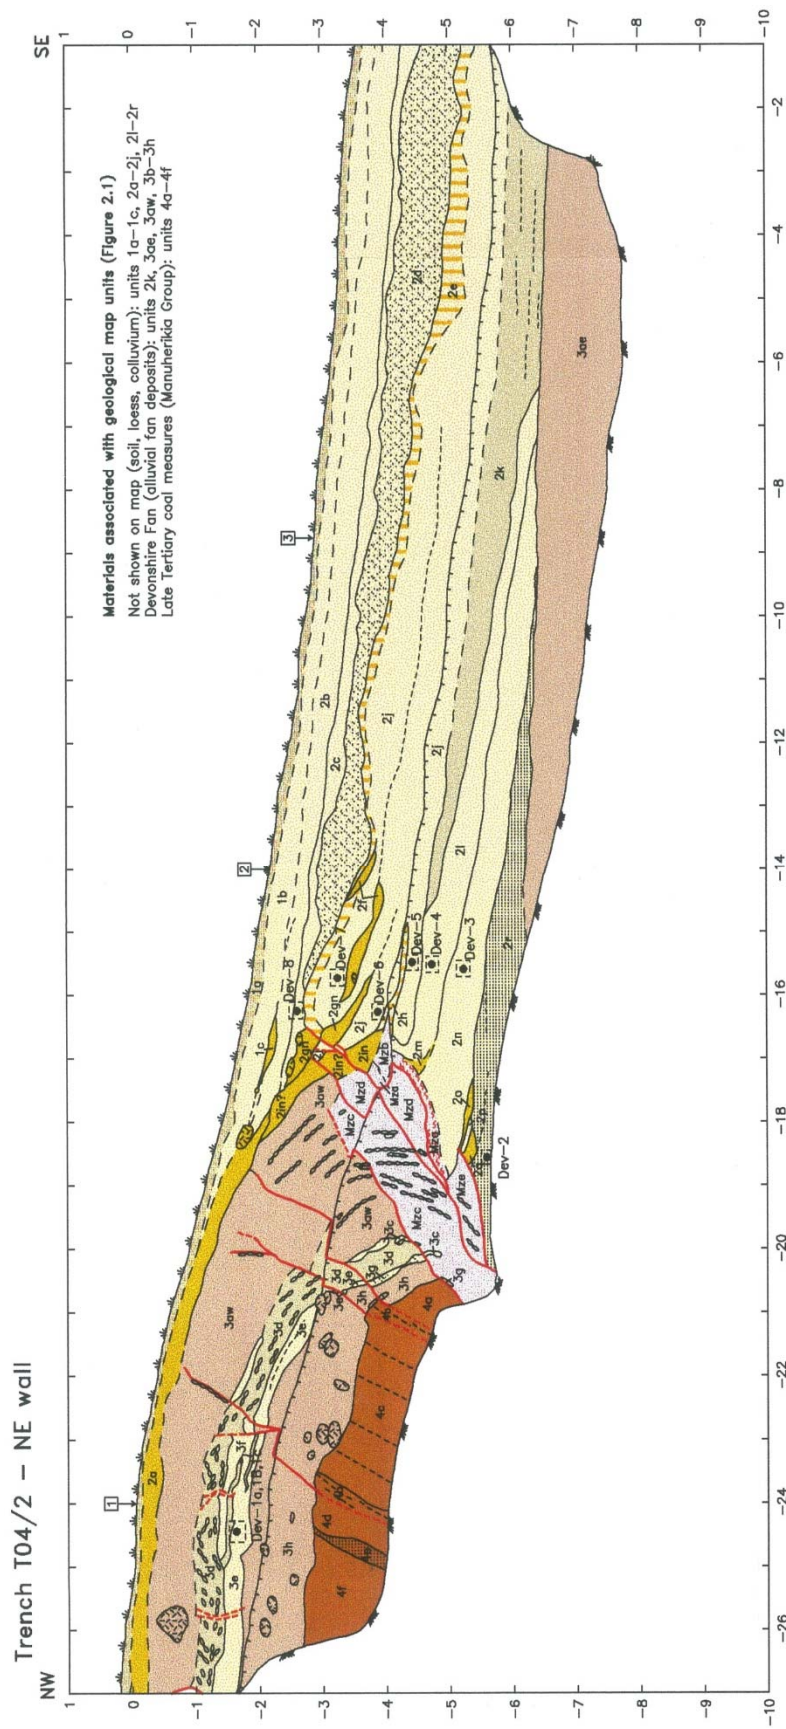
Figure 8: Log of fault investigation trench T04/2, Devonshire.
