**Processing gold-bearing quartz ore in the early twentieth century: an illustrated case history from the Snowy River battery, Waiuta, New Zealand**

*Geoscience Society of New Zealand miscellaneous publication 142*

The Snowy River battery near Waiuta, New Zealand, processed gold-bearing quartz ore from the nearby Blackwater mine between 1908 and 1938. Incorporating the latest technology when built in 1908, it was a typical, early 20th century processing plant. This case study of how gold was extracted from the ore is illustrated by a sequence of photographs taken by Joseph Divis in early 1931.

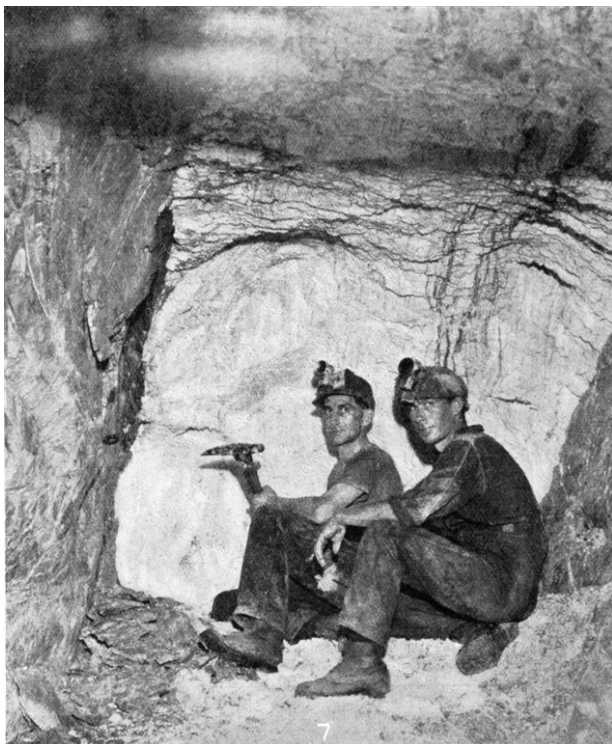
**Figure 3.** Quartz reef (white), locally up to 1.7 metres wide, at no 14 level in the Blackwater mine, with darker greywacke country rock on both sides.

The light-coloured quartz contrasted with the much darker greywacke (Greenland Group) country rock (Fig. 3). The miners tried to extract all the quartz, with as little greywacke as possible. Inevitably, however, the quartz ore taken out of the mine always contained a varying amount of barren country rock.

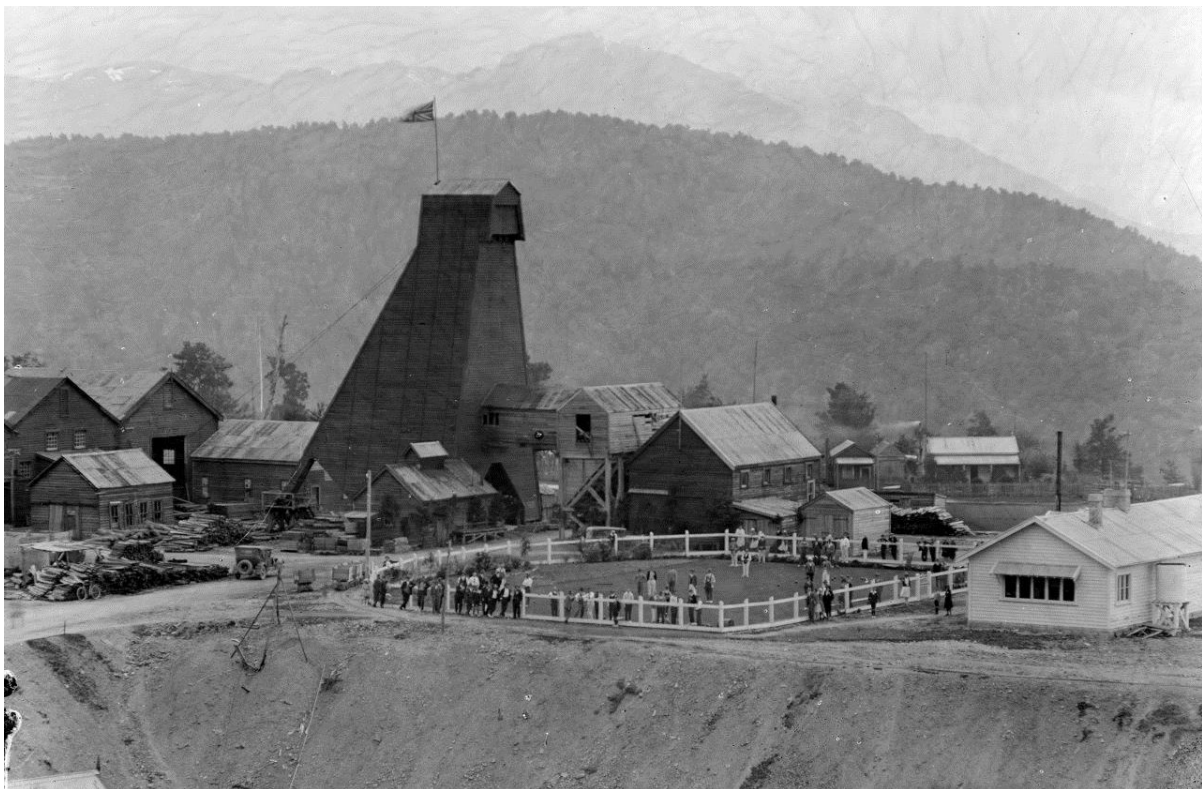
**Figure 4.** Poppet head over the Blackwater shaft, and surrounding mine buildings. The large amount of mullock (waste rock) from the mine was dumped near the shaft, and in 1931 was smoothed out to make a bowling green for the community at Waiuta.

While the mining company would have preferred to concentrate on extracting quartz, the miners had to spend a considerable amount of time tunnelling through barren greywacke to form tunnels and shafts, and to enlarge their working spaces. The barren rock (mullock) was hoisted up the Blackwater shaft to the surface where it was mounded up as mullock heaps, and later spread out (Fig 4).

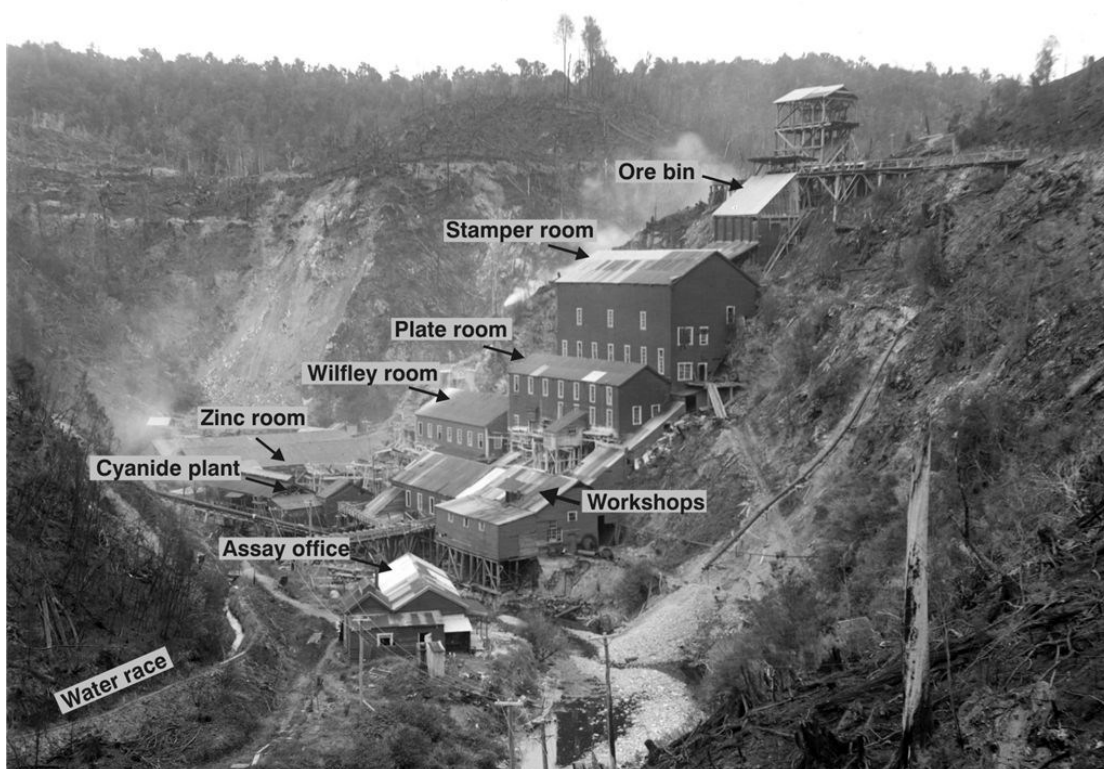
**Figure 5.** View of the Snowy River battery, with buildings labelled.  
*Alexander Turnbull Library, 1/1-39807-G*

The Snowy River battery was sited on the side of a steep valley (Fig. 5) so that gravity could be used to move the ore as it was processed through different stages of gold extraction.

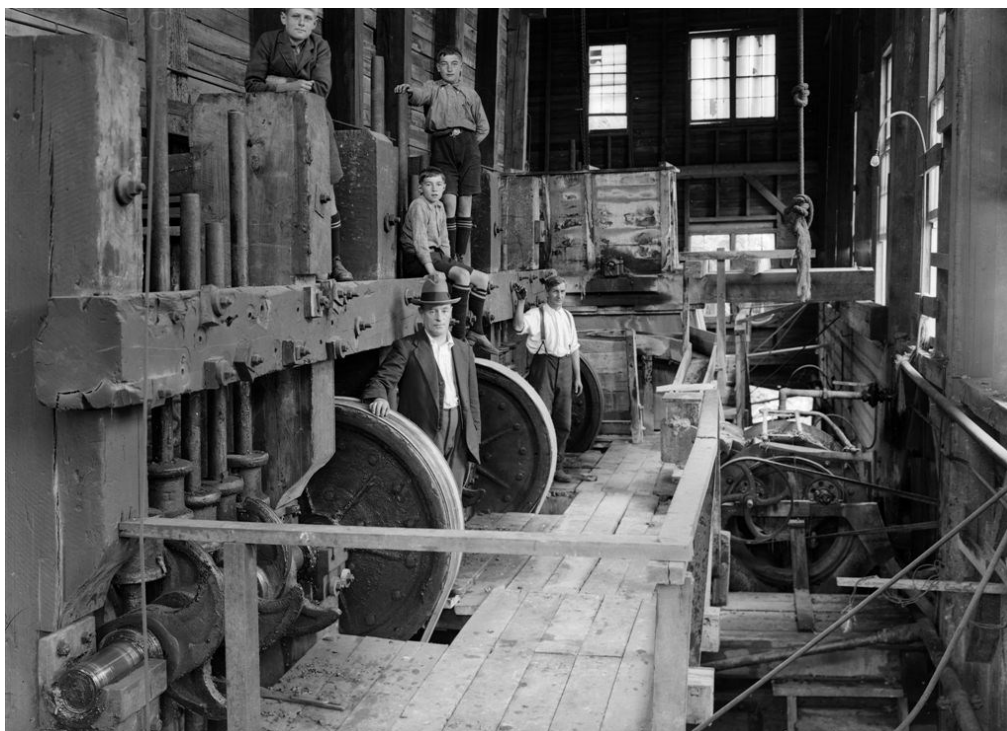
**Figure 6.** Sets of five stampers were operated by belt driven bull wheels. The finger-like cams (lower left) lifted and dropped the stampers to crush the quartz in mortar boxes (see Fig. 7). *Alexander Turnbull Library, ½-233103-G*

Automatic feeders allowed stone to fall into apertures behind the mortar boxes, large iron structures resembling upright pianos, where stamper shoes at the bottom of the stamper rods pounded against replaceable dies, and crushed the quartz to a powder (Figs 6 & 7). The rods were lifted by curved finger-like cams on shafts, driven by belts from the battery's Pelton water wheel. The operation of the stampers was incredibly noisy, but in the 1930s no-one wore any hearing protection.

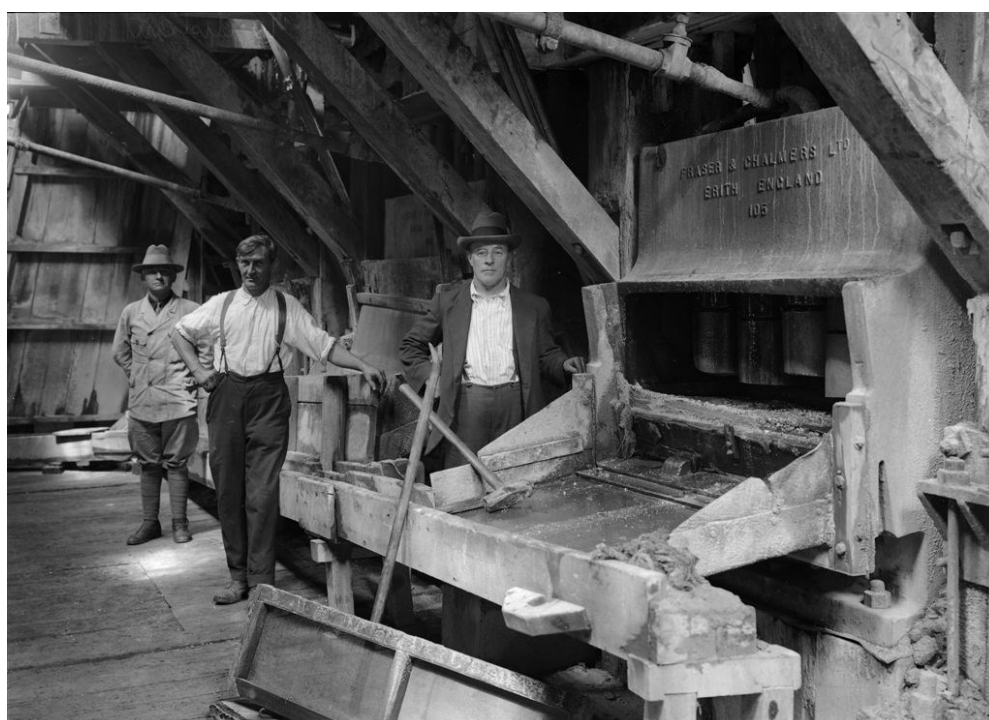
**Figure 7.** Mortar box with the front removed, showing five stamper shoes. The quartz ore mixed with water was pounded by the stampers to produce a slurry. *Alexander Turnbull Library, ½-233105-G*

Water was fed into each mortar box during crushing, to produce a pulp (slurry) that passed through a mesh screen in front of the mortar box. A launder – an open timber flume – took the pulp through to the plate room for the first stage of recovery.

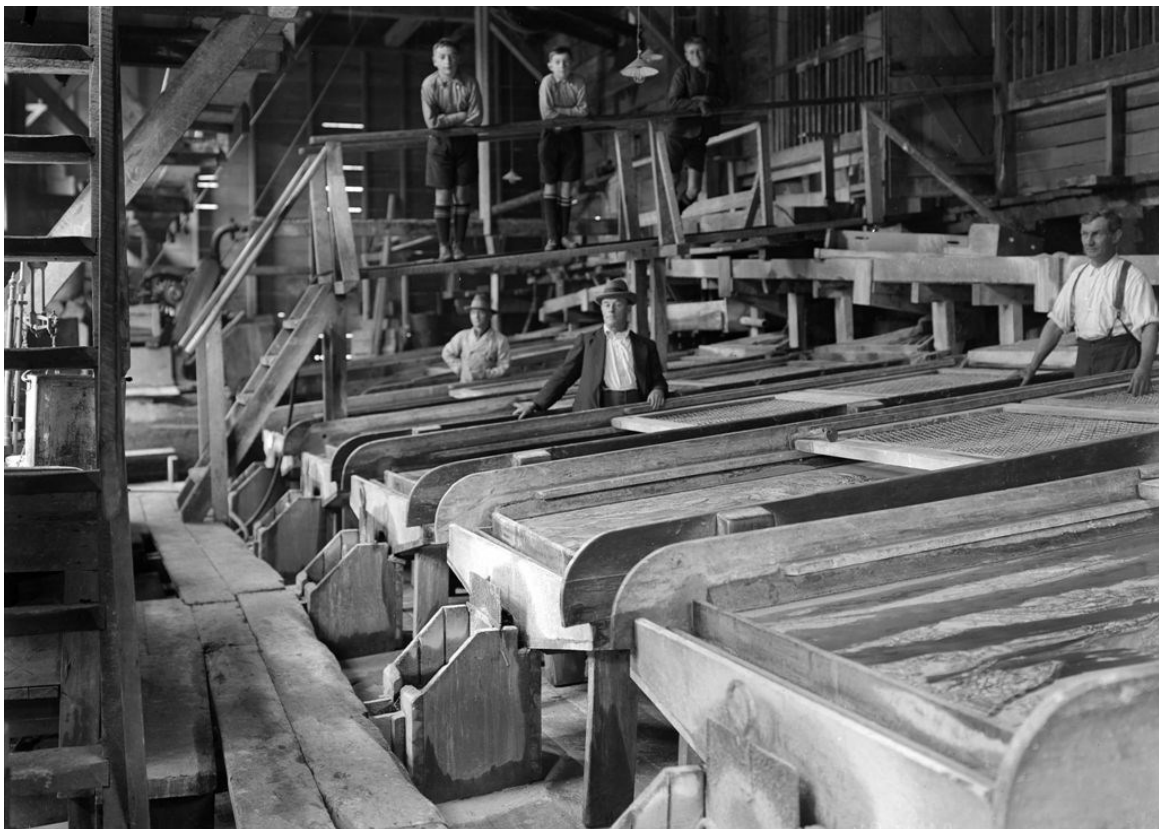
**Figure 8.** The plate room, where the slurry flowed over copper amalgamating plates coated with mercury. Fine gold amalgamated with the mercury, and was stuck to the coated plates.  
*Alexander Turnbull Library, 1/2-233106-G*

Within the plate room, the pulp flowed to spreaders at the head of nine copper amalgamating plates (Fig 8). Each plate was 3.5 x 1.45 metres, highly polished, and laid on a slightly inclined table. The plates were smeared with a chemical agent so that mercury poured on to it formed an even film all over the copper surface.

When the pulp flowed over the treated copper plates, the fine particles of gold amalgamated with the mercury coating on the plates. The rest of the pulp flowed away in a launder for further treatment apart from the sand fraction that fell into a trap at the bottom of each table. All the plates were carefully scraped each morning, the amalgam was placed in a basin, and the plates were re-coated with mercury.

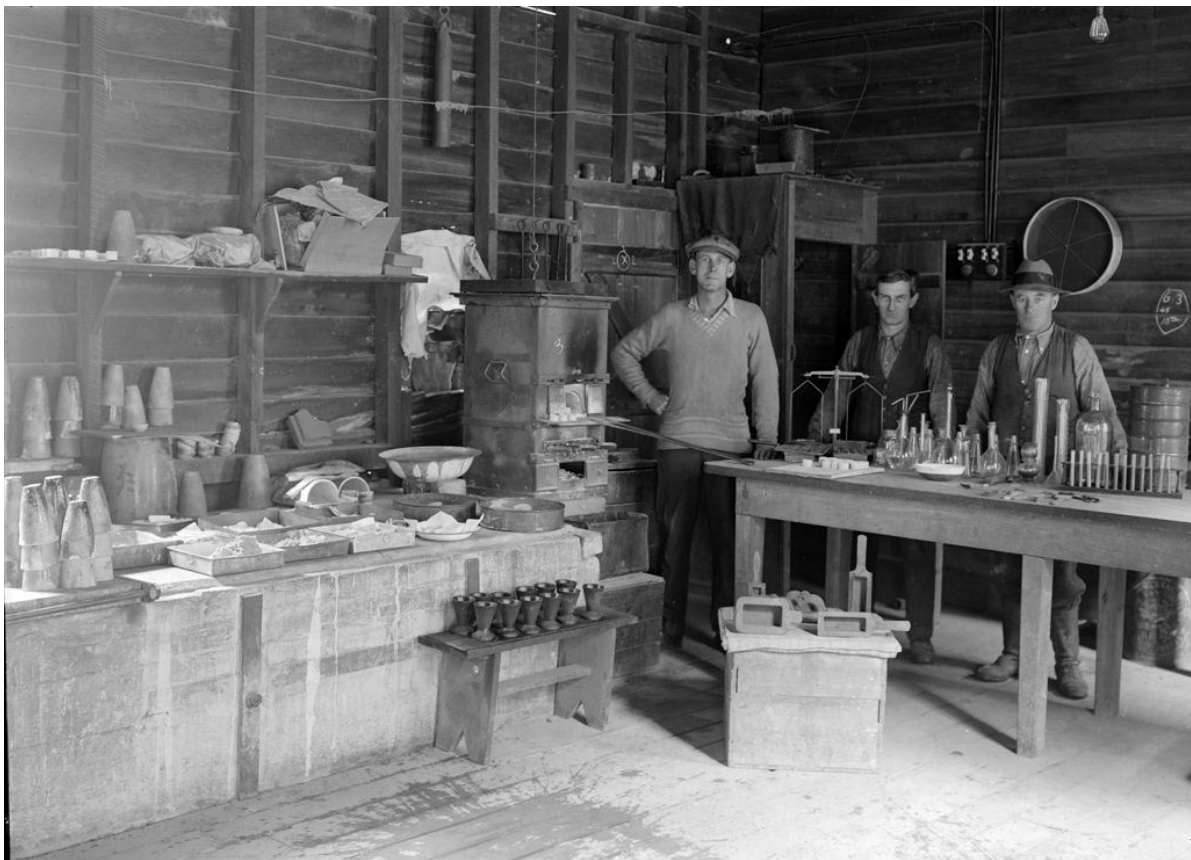
**Figure 9.** The gold content of the ore was checked at several stages from when it left the mine to the final smelting in the assay office, across the river from the battery. From left, the staff are Ted Allen, Frankie Orr and Jack McEwin.

Gold values were routinely checked at all stages of the process in the assay room (Fig 9).

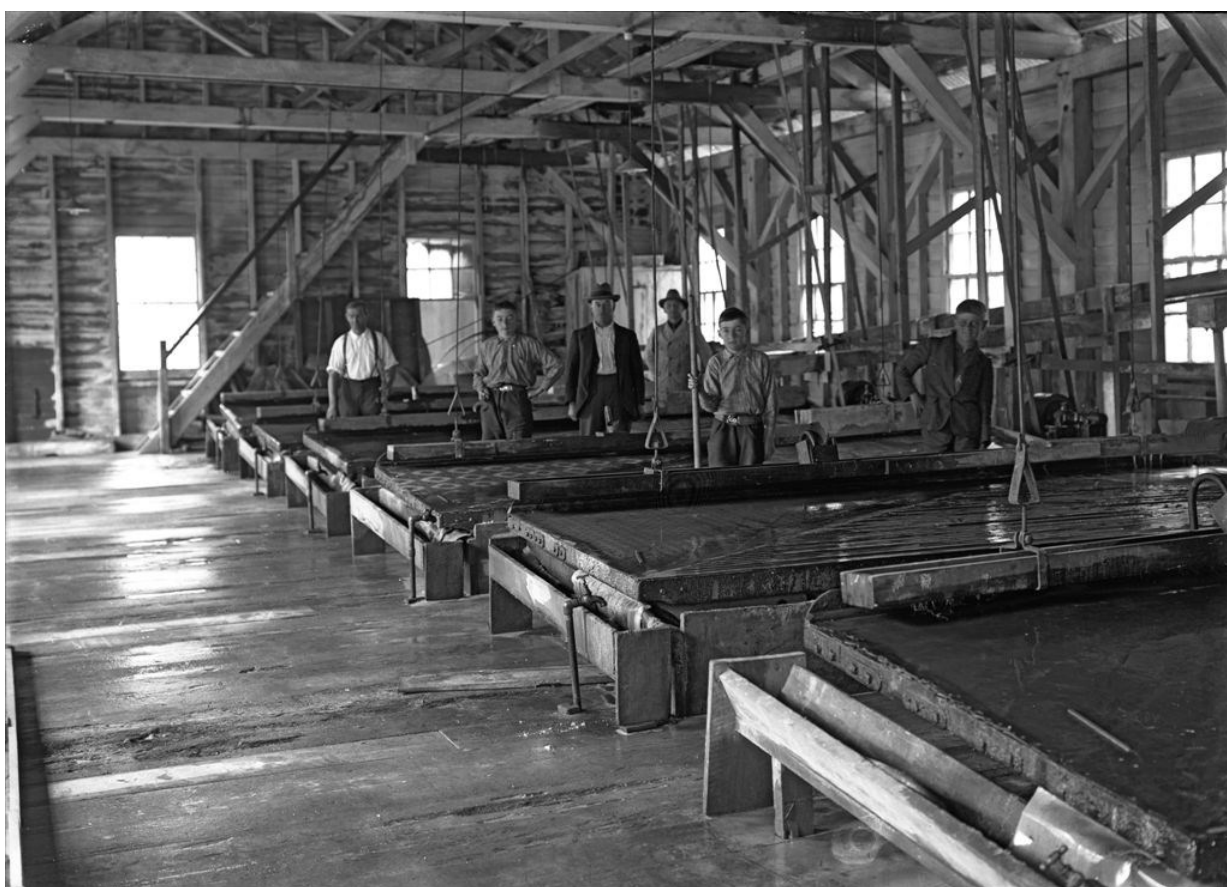
**Figure 10.** In the Wilfley room sands were washed across tables with riffles to concentrate heavier grains – largely gold and sulphides. The concentrates were again passed over amalgamating tables to catch any free gold, and then sent to the roasting furnace.

A launder took the sands to the Wilfley room, with seven Wilfley concentrators – inclined tables covered with heavy linoleum and narrow wooden laths, forming thin, tapering riffles (Fig 10). A lengthwise to-and-fro motion caused the denser grains (gold or gold-rich material and metallic sulphides) to be caught against the riffles, while the remainder (sands or pulp) flowed over them. The concentrates were then passed over two further copper amalgamating plates to catch any free gold. The remaining sand concentrates contained gold, mainly within sulphide grains, but initially could not be effectively processed in New Zealand. It proved too expensive to ship the concentrates to Australia, so they were stockpiled.

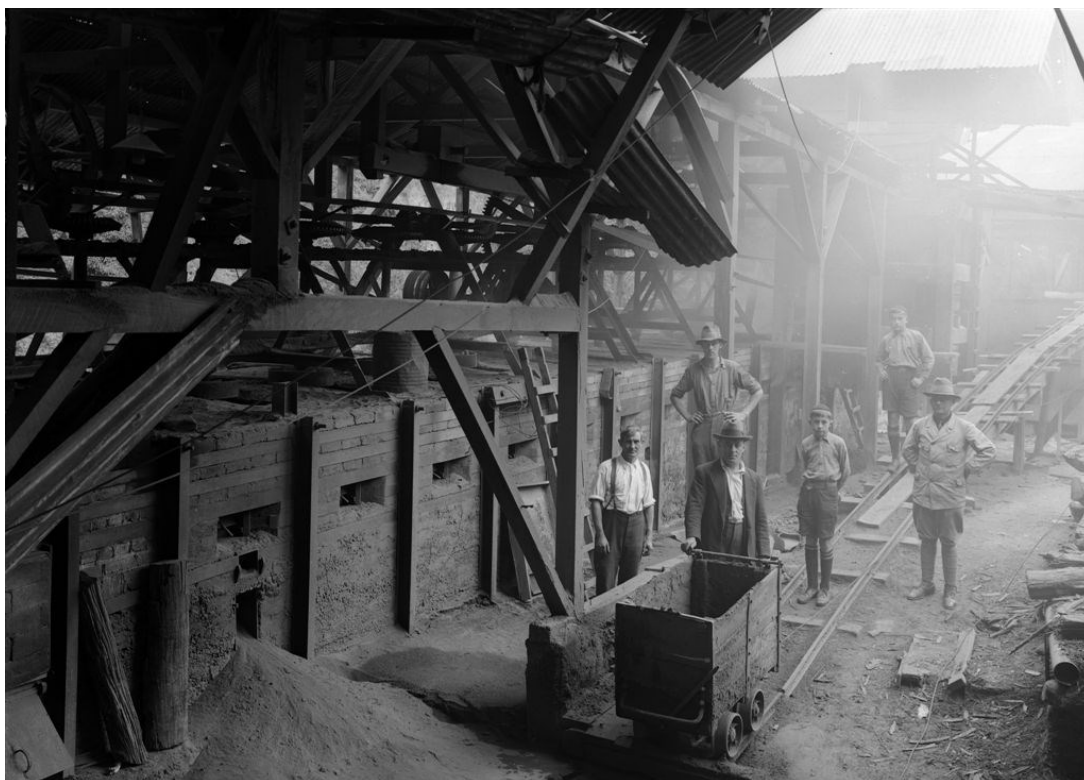
**Figure 11.** View outside the Edwards roasting furnace, on the Snowy River flats. Sands that have been roasted can be seen on the bottom left, and these were then transported to the cyanide plant.

In 1924 an Edwards roasting furnace was installed at Snowy River (Fig. 11). The dark sand concentrates, containing a high proportion of sulphides were passed through the furnace, and agitated by a series of revolving arms. By the time the sand emerged some of the mineral components had been oxidised, which allowed higher gold recoveries treatment in the cyanide plant.

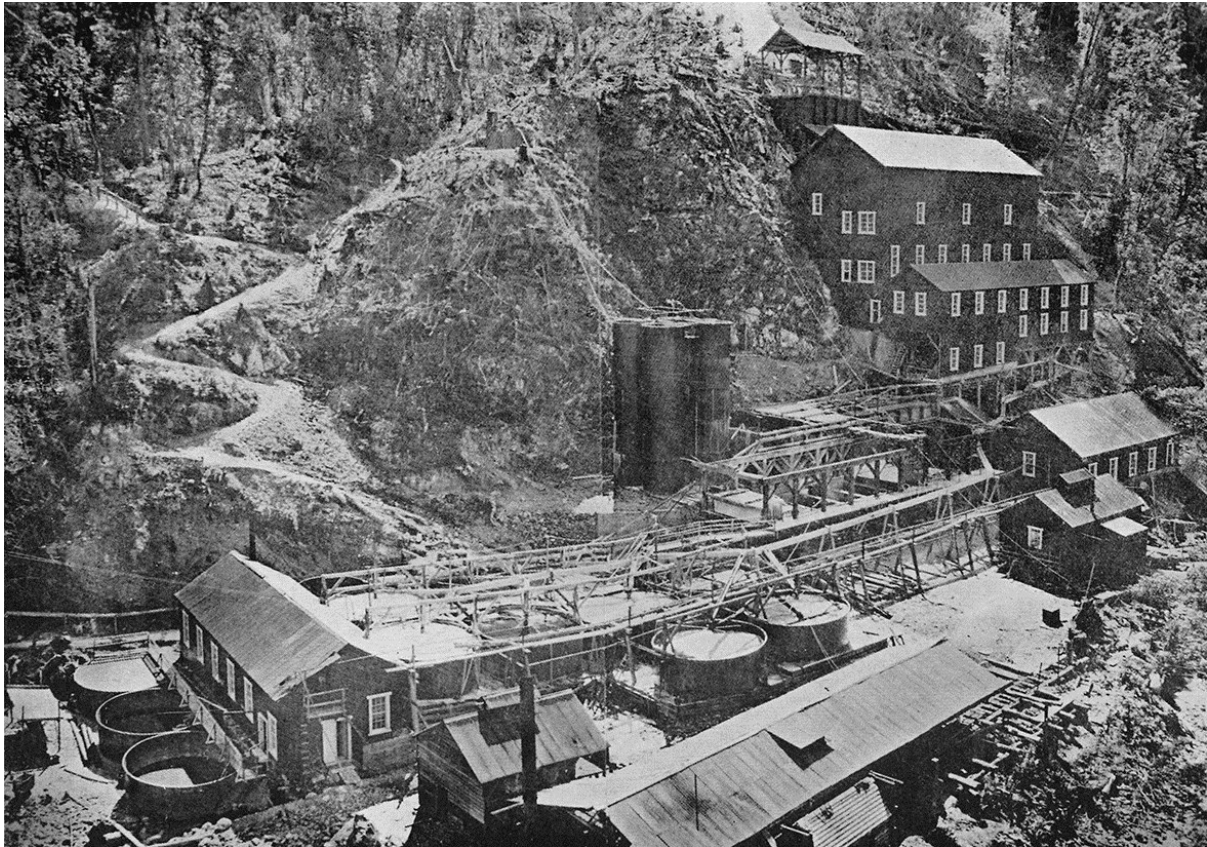
**Figure 12:** View across Snowy River, close to river level, showing the cyanide tanks and associated buildings in the foreground, taken about 1914. The cyanide tanks were later roofed over. *Henderson (1917, p 172), Plate X*

In the late 19<sup>th</sup> century it was realised that fine gold would dissolve in dilute cyanide solutions, and could be precipitated by reaction with zinc. By the time the Blackwater battery was built in 1908, cyanidation by the MacArthur-Forrest process had become a standard process to recover fine gold that had not been recovered by amalgamation (Fenby 1999, Park 1896). After Wilfley treatment and roasting, the remaining pulp and sands went through the cyanide process at the lowest part of the battery site, adjacent to the Snowy River (Fig 12).

Slimes from the spitzkasken were also treated by cyanidation in four 12 metre tall agitator tanks (Fig 12, centre). Compressed air was blown through the slimes in order to prevent an impervious layer forming, and it also maintained an oxygenated solution that was needed for gold dissolution. Settling and filtration were used to separate the dust-size slime particles, and once a clear solution was obtained it was treated in the zinc room.

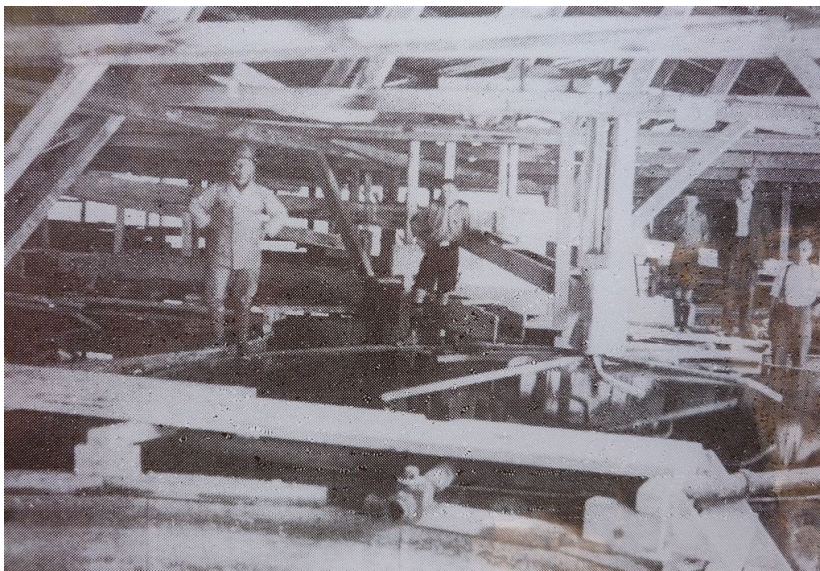
**Figure 13.** Joseph Divis (left) and others standing on one of the cyanide vats, with rotating distributors in the centre. Unfortunately the original of this image cannot be located, and only a poor print is available.

The cyanide plant included 13 large steel vats. Sands from the spitzkasken and Wilfley concentrators as well as the roasting furnace were carried into the vats, and evenly spread by rotating distributors. The fluid was drained off through a calico filter in the bottom. The drain taps were then shut off, and a solution of 0.4% NaCN run in. As the cyanide solution percolated through the sands, the fine gold started to dissolve, and the solution was run off to the zinc room. Each vat load of sand was treated with cyanide three times, the solutions becoming progressively weaker. Finally, the sands were washed into the Snowy River.

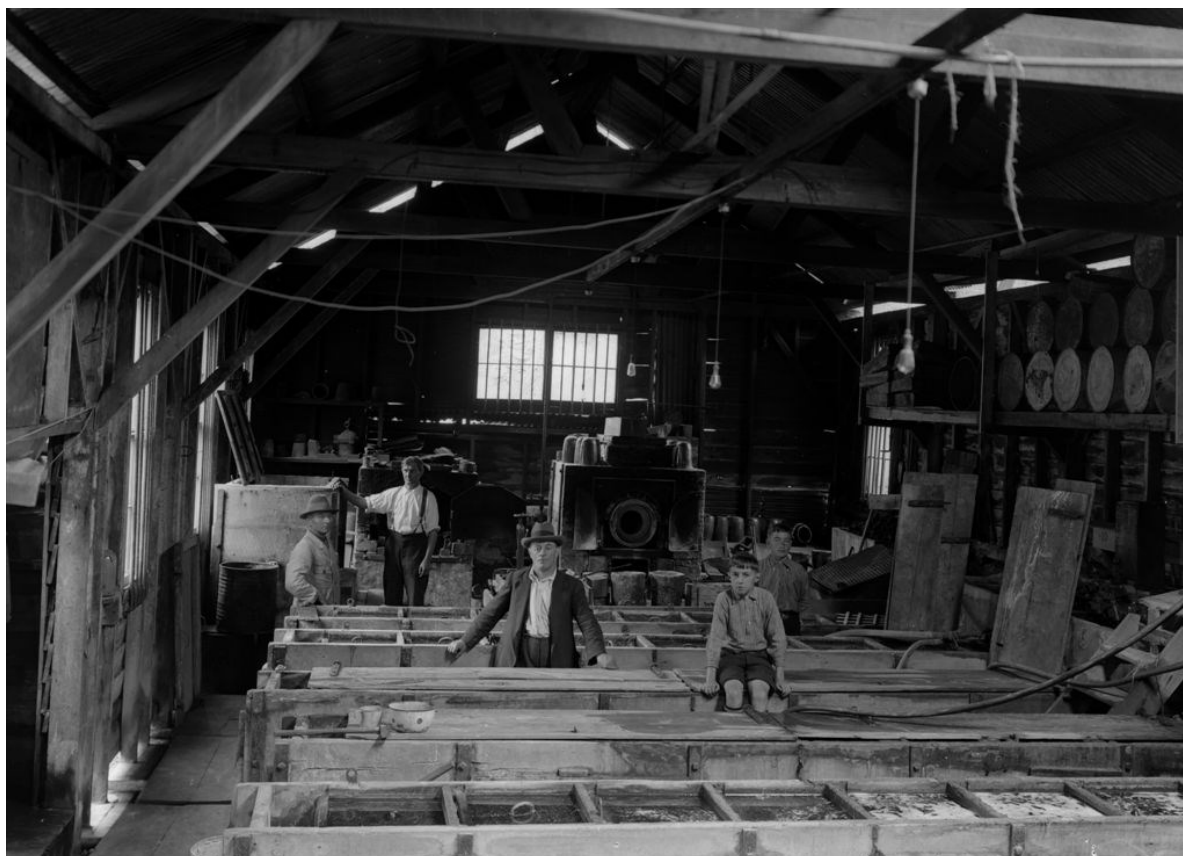
**Figure 14.** The zinc room, where the gold-cyanide liquid was piped through zinc boxes containing zinc filings. A thick slime rich in gold precipitated at the bottom of the boxes, and was collected regularly.

In the zinc room the gold-cyanide solution from the vats was run through partitioned boxes, each space containing a grating fitted with a central handle that was filled with zinc shavings (Fig. 14). Zinc reacted with the cyanide solution to precipitate a fine sludge rich in gold. This sludge was regularly washed out of the zinc boxes, treated with acid and dried ready for smelting.

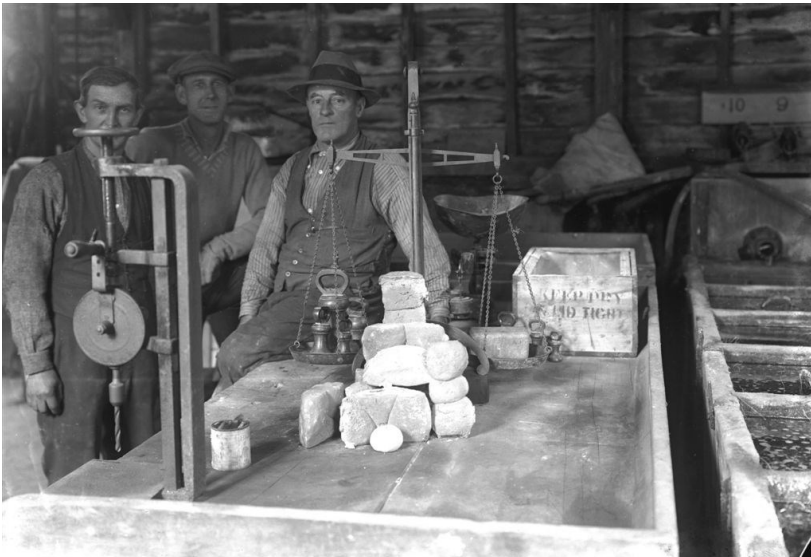
**Figure 15.** When amalgam was heated in a retort the mercury was driven off and condensed, leaving behind sponge gold, which was later refined. The white egg-shaped lump in the front is amalgam, while the others are sponge gold.

Scales in the background were used for weighing the gold while the drill at the left front was used to obtain samples for assay.  
*Hocken Collections, S08-221n*

The final stage of the process was to recover the gold, normally done monthly by the battery manager and senior staff. For mercury-gold amalgam it was a simple process to heat the amalgam in a retort to recover the mercury by condensation, leaving behind sponge gold (Fig. 15). This was melted at a higher temperature and the molten metal poured into moulds to form gold bars (Figs 16 & 17).

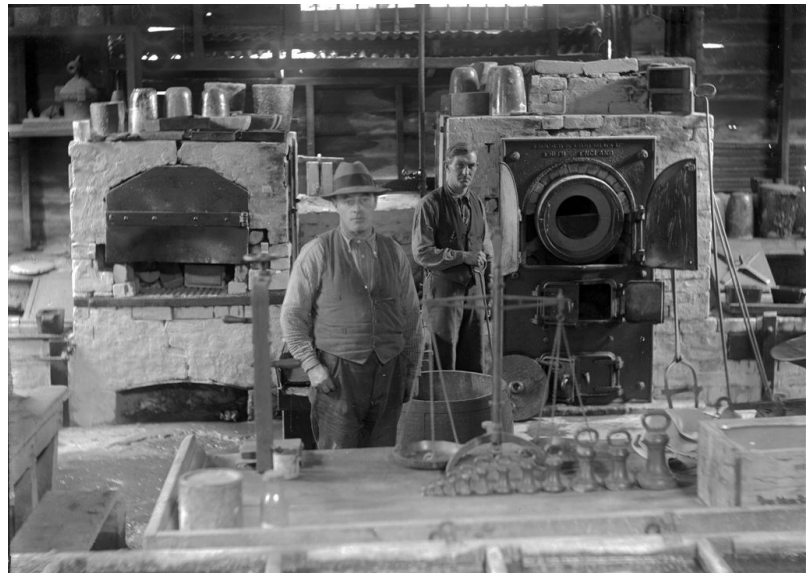
**Figure 16.** The furnaces at the end of the zinc room were used to refine the gold sludge as well as the final refining of the sponge gold when it was melted and poured into gold bars.

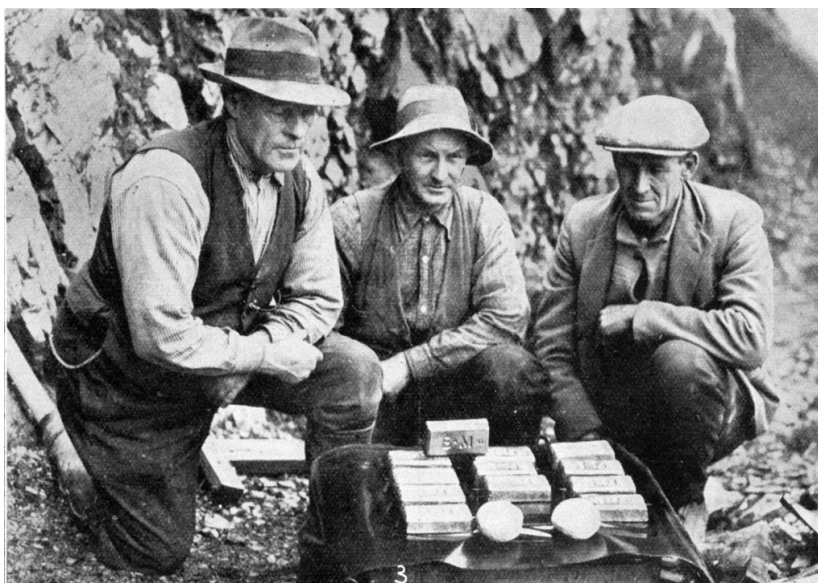
**Figure 17.** The final result – a dozen gold bars, stamped BM for Blackwater mine – with Jack McEwin, Frankie Orr and Ted Allen keeping careful watch.

With each bar weighing 112 ounces, there is over \$NZ 1 million (2015 value) of gold on display.

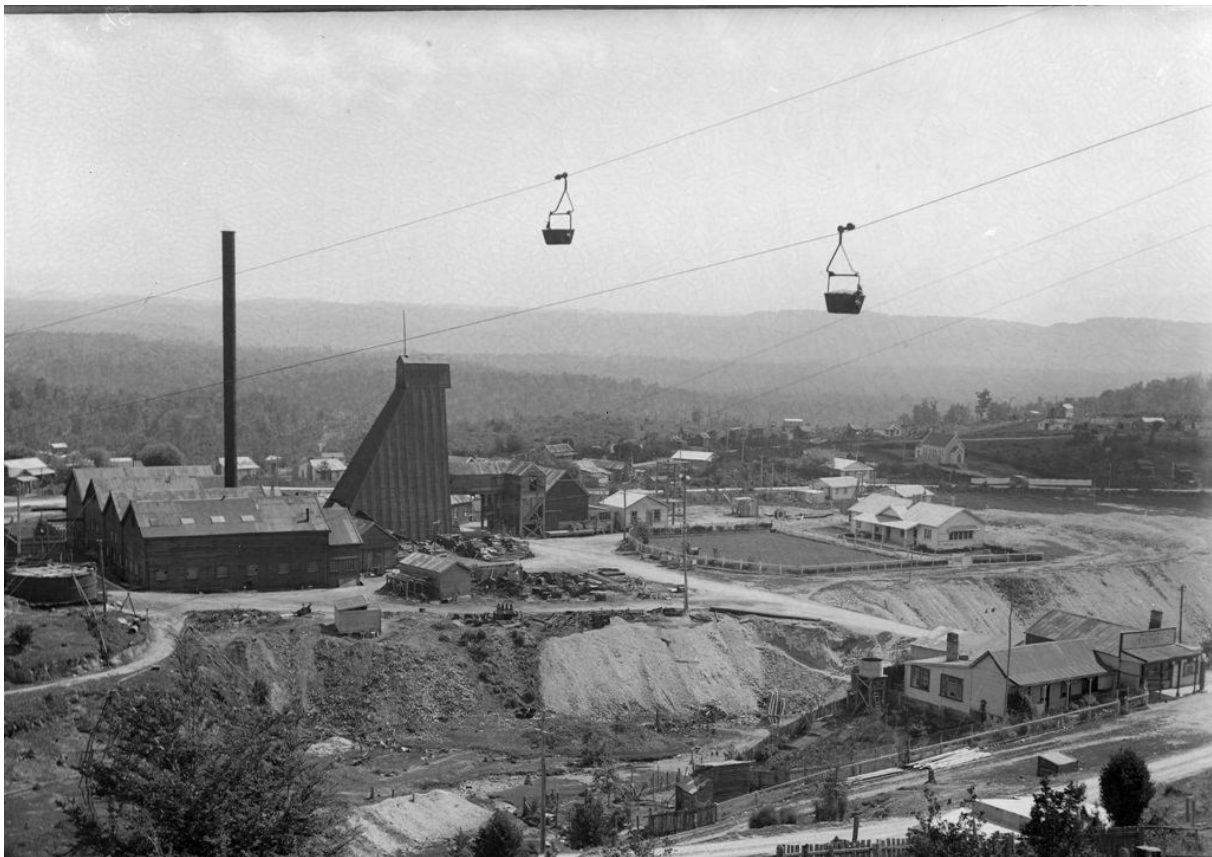
**Figure 18.** Ore buckets on the aerial ropeway from the Prohibition shaft pass over the Blackwater shaft and the town of Waiuta on their way to the Snowy River battery.

Initially a 1.6 km aerial ropeway was built to transport ore from the Prohibition shaft across the town of Waiuta to the Snowy River battery (Fig. 18). It became necessary to install additional stampers to deal with the increased production of ore, and the battery was working at maximum capacity.

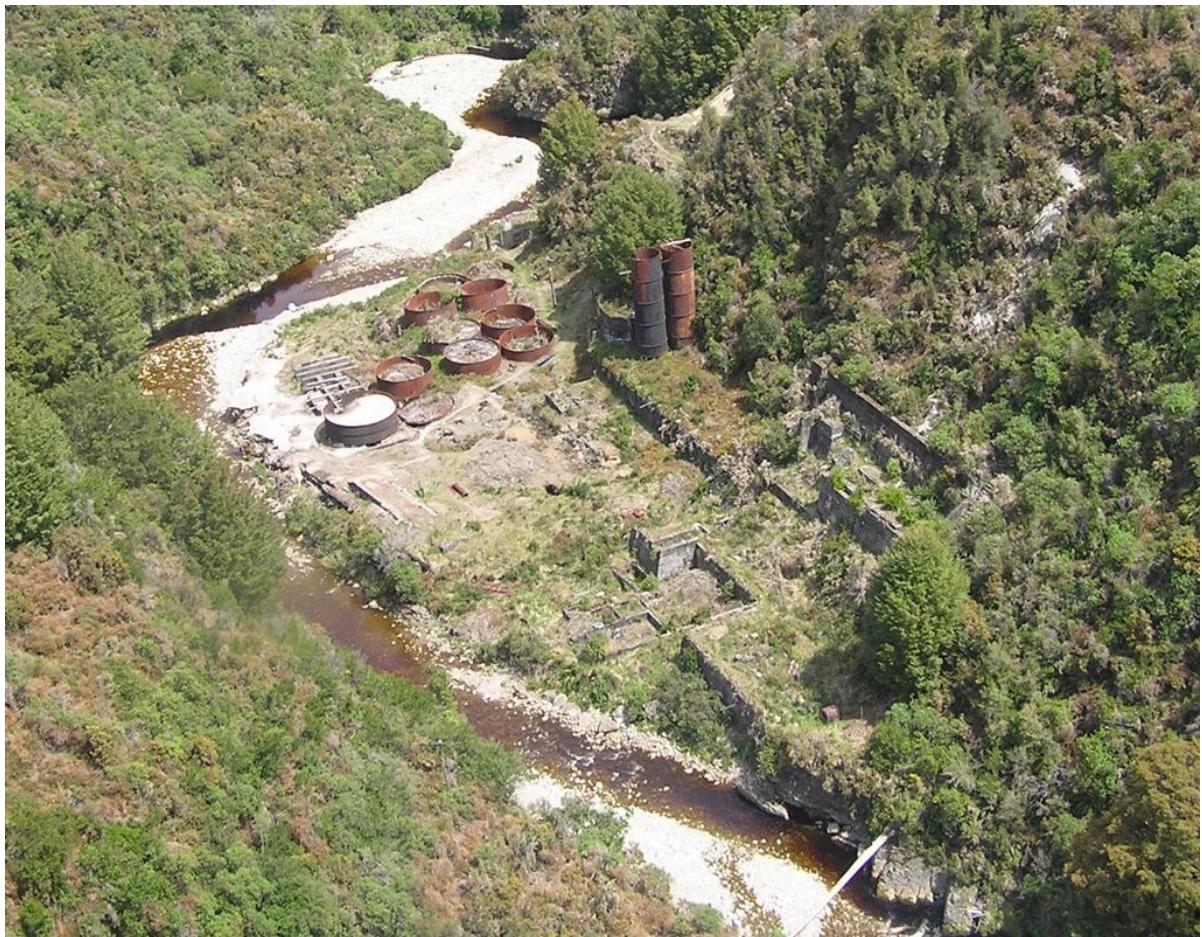
**Figure 19:** View across the Snowy River showing the remains of the battery in 2007.

The Snowy River battery is an important feature of the historic Waiuta town site, administered by the Department of Conservation. It can be reached on tracks from Waiuta or Snowy River. Although the native forest is regenerating and the buildings have disappeared, the footprint of the processing plant is still clear (Fig 19).

Impressive concrete foundations, built against the western wall of the valley, are the dominant feature of the battery site, and include the floors of most of the buildings shown in Fig 5. Many of the large iron tanks for the cyanide plant remain. In general most of what was directly on the ground remains, while most of the superstructure and equipment has been removed.

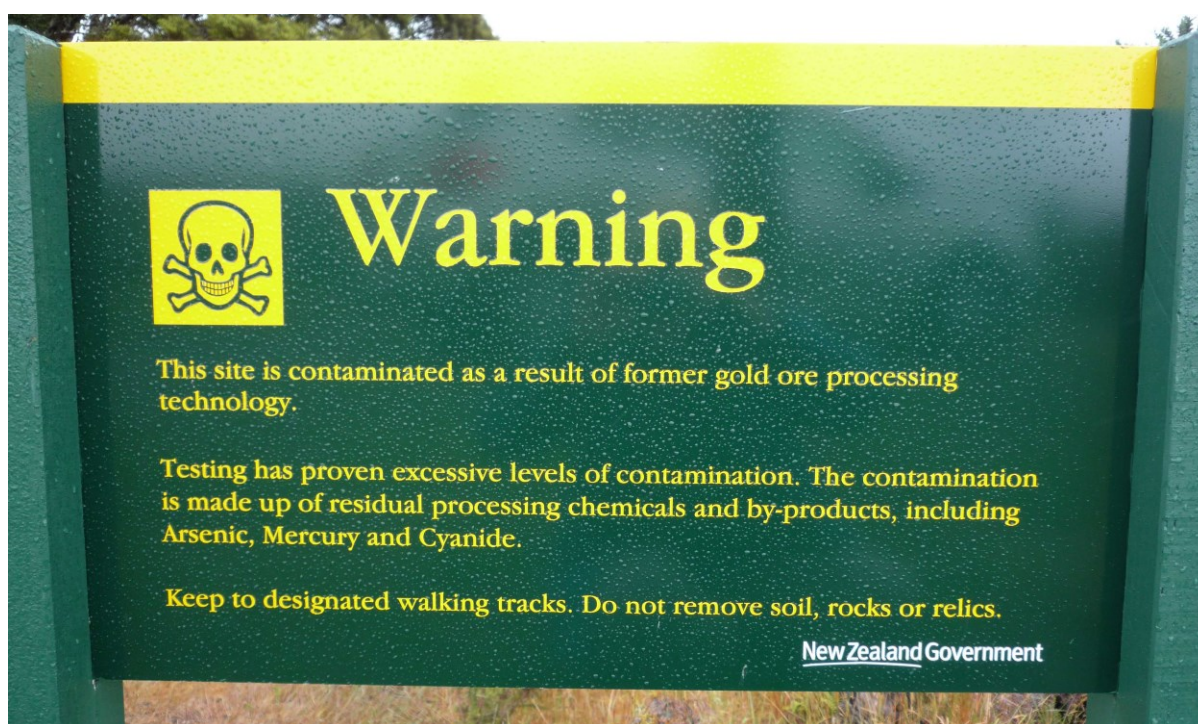
**Figure 20:** Sign near the site of the Edwards roasting furnace on the edge of Snowy River warning visitors of the danger of contamination. Arsenic is the main contaminant. Cyanide rapidly oxidises, and is unlikely to be a problem such a long time after the plant closed.

Both the ore and country rock contain small amounts of arsenopyrite, which is oxidised by roasting to form haematite, arsenolite ( $\text{As}_2\text{O}_3$ ), and sulphur dioxide. The arsenolite emerged as a vapour which spread over the surrounding area. Recent studies have shown that the unvegetated areas around the roaster are underlain by a light greenish-grey surface crust, up to 30 cm thick, enriched in arsenic. Reconnaissance arsenic analyses of surface materials were consistently above maximum recommended levels (0.02 wt %) (NEPC 1999; Haffert & Craw 2008). Signs warn visitors of the contamination near the roaster site (Fig 20), which has now been fenced off and capped with gravel.
