GEOLOGICAL SOCIETY OF NEW ZEALAND

# Geosciences '06 - Our Planet, Our Future

## Field Trip Guides

**LANDSLIDE AND SLOPE INSTABILITY HAZARDS AFFECTING  
PAEKAKARIKI, THE SH1 COASTAL HIGHWAY, AND THE  
PROPOSED TRANSMISSION GULLY MOTORWAY ROUTE**

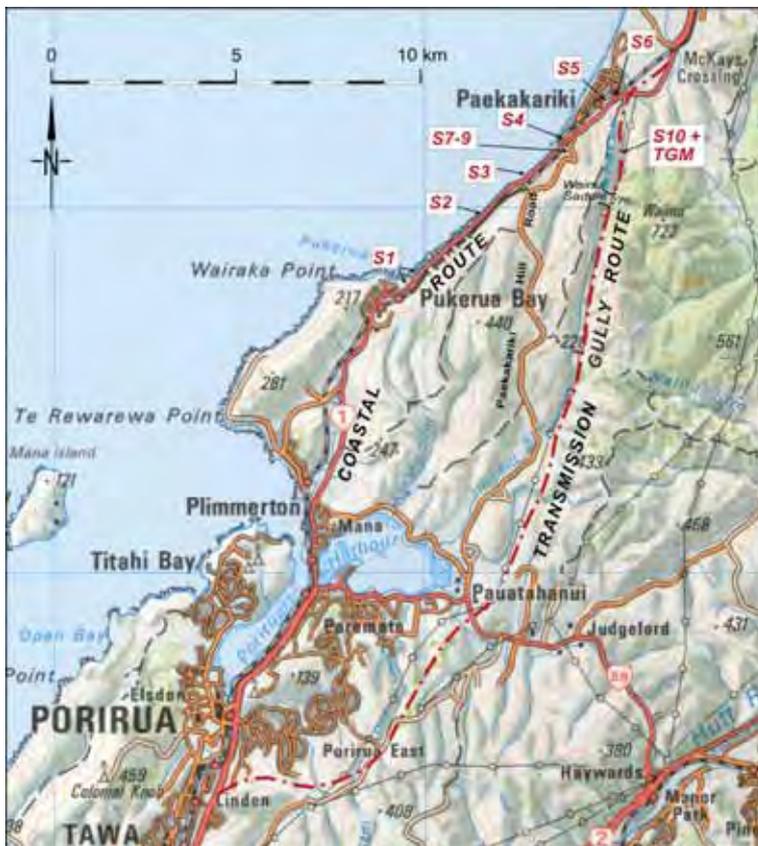
**Figure 1.** Map showing the location of SH 1 north of Wellington (the Coastal Route) and the proposed Transmission Gully Motorway. This field trip will begin at Paekakariki Railway Station and head south to the top of Pukerua Bay Hill for the first stop (S1). We will travel north up the coast, stopping where possible to view features of interest (locations are limited by road works). Stops along SH 1 and the Paekakariki Hill Road are as shown (S2-9). We will then proceed up Te Puka Stream, along the northern end of the TGM route to Wainui Saddle, crossing the Ohariu Fault in the upper valley (Figure 2). This will allow us to look at and discuss the potential geotechnical difficulties for construction of the TGM highway in the narrow fault-controlled valley.

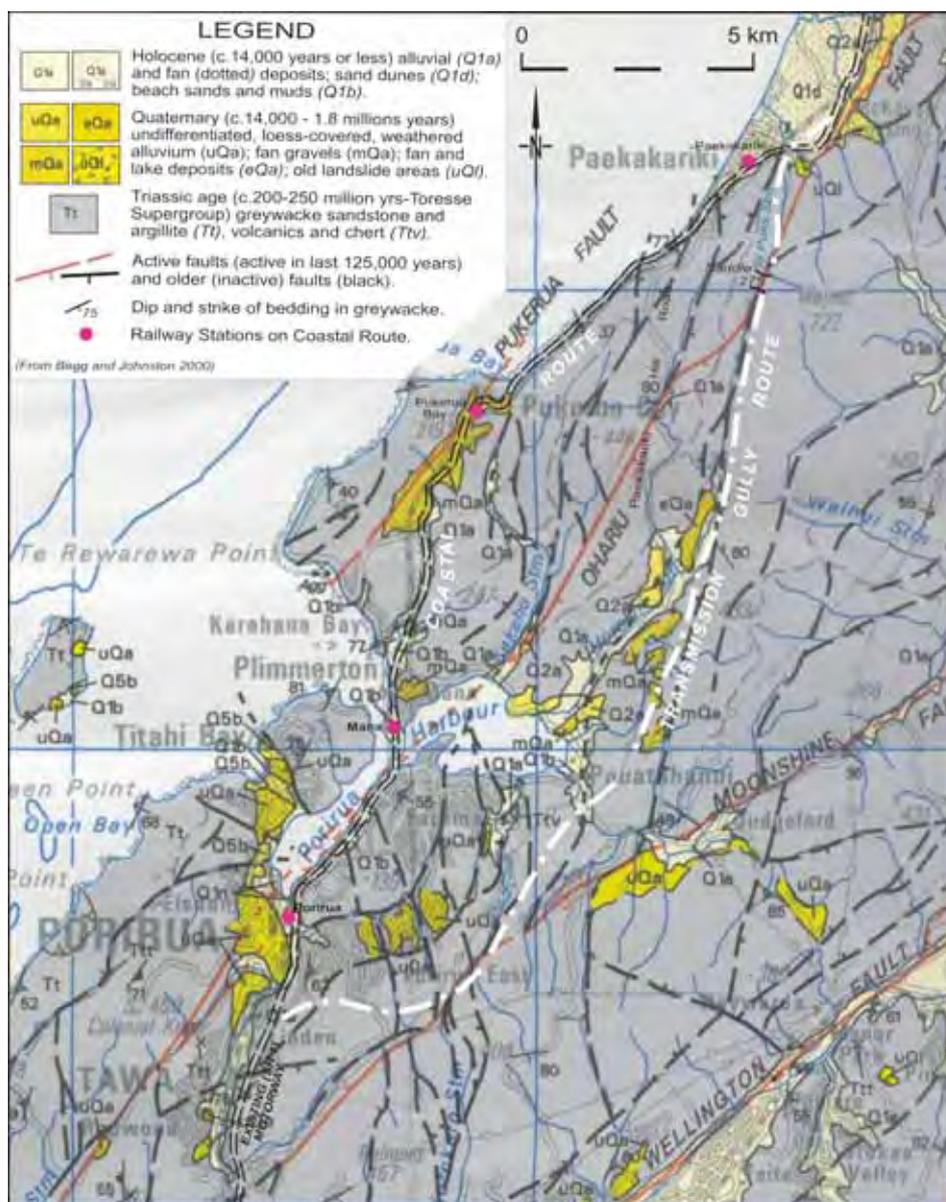
**Figure 2.** Geological map of the northern Wellington area showing main rock types, areas of recent and older alluvium, loess, and fan gravels, and geological structures in relation to the Coastal and Transmission Gully Motorway routes. Note that both routes are aligned along major active faults that are considered to be potential areas of fault rupture hazard that must be taken into account (after Begg and Johnston 2000<sup>8</sup>).

The regional geology of the northern Wellington area where the Coastal Highway and the proposed Transmission Gully Motorway route are located is shown in Figure 2 (from Begg and Johnston 2000). This shows that the hills and coastal slope from Pukerua Bay to Paekakariki across to the Transmission Gully route are formed of 'greywacke' bedrock – hard, interbedded sandstone and argillite (siltstone). The greywacke rocks have been folded and faulted by several phases of deformation, and as a result are sheared and closely jointed (100-500 mm spacing). Bedding is variable throughout the region, but north of Pukerua Bay it generally dips steeply (50°–80°) to the east and northeast into the coastal slope (Figure 3). There are extensive bedrock exposures on the rock platform along the coast foreshore and in road cuts along SH 1 and the railway line [STOPS 1b and 2].

The main geological structures in the region are active faults\* and old faults (Figure 2). Two major active faults are mapped in the area. The Pukerua Fault passes through Pukerua Bay and is inferred to continue offshore. The Ohariu Fault extends from Porirua Harbour through the hills to the north, and at the northern end along Te Puka Stream on the western side of the TGM route. The TGM would cross the Ohariu Fault on the northern side of Wainui Saddle (Figure 3), either on a bridge or cut and fill (discussed later).

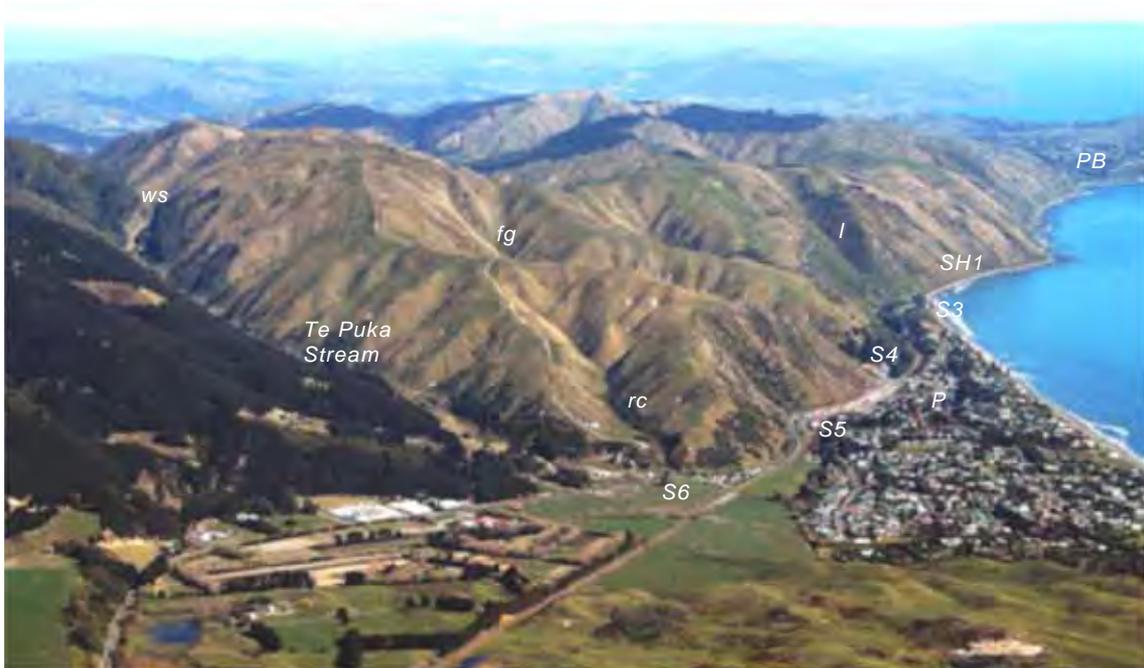
**Figure 3.** Aerial view looking south along the coast from Paekakariki (*P*) to Pukerua Bay (*PB*). It clearly shows the marked geomorphic differences between the Coastal Route, with the steep coastal cliff above *SH 1*, and the proposed Transmission Gully Motorway route, the northern part of which follows the strongly linear valley of Te Puka Stream. Other features shown here that will be seen on the field trip include the Fly-by-Wire Gully (*fg*), Reservoir Creek (*rc*), Wainui Saddle (*ws*), and the topographic lineament (*l*) near the Fisherman's Table Restaurant [*S3-6* - locations of *STOPS 3, 4, 5, 6*].

The coastal section of SH1 between Pukerua Bay and Paekakariki lies at the foot of a steep wave-cut slope, which rises to a height of about 150–250 m at an average slope of about 40°. However, there are also many very steep (50–60°) rocky bluffs and spurs (Figures 3 and 4). The slope is dissected by several deeply incised streams which extend from the ridge crest to the coast, where they have discordant junctions due to geologically recent uplift. The streams are separated by steep bedrock spurs with broad truncated triangular ends, through which railway tunnels have been excavated. The lower slope has also been modified in places by fills for the NIMT railway line and road embankments, near-vertical unsupported rock cuts between the tunnels, along SH 1, and in two places near Paekakariki by quarrying for railway line ballast (Figure 4). The slope is now mainly grass-covered, but was formerly clad in native scrub and bush, of which a few small remnant areas remain. The toe of the slope has been protected from wave erosion since the road and concrete sea wall was completed in the late 1930s.

North of Pauatahanui the TGM route follows the linear courses of Horokiri and Te Puka streams, rising from near sea level to about 275 m at Wainui Saddle (Figures 3 and 4). Slopes along the TGM route extend up to 200 m above proposed road level at an average slope of about 25°, more gently than along the coastal highway. Apart from superficial soil and debris slides there are no identified large bedrock slides along the TGM route. The very large (about 4 million m<sup>3</sup>) prehistoric landslide at the northern end near SH 1 (Figure 4) may have occurred as result of the last movement on the Ohariu Fault about 1000 years ago (Begg and Johnson, 2000; Langridge et al. 2005). This old landslide is inactive, and does not impact on and will not be affected or modified by the proposed motorway.

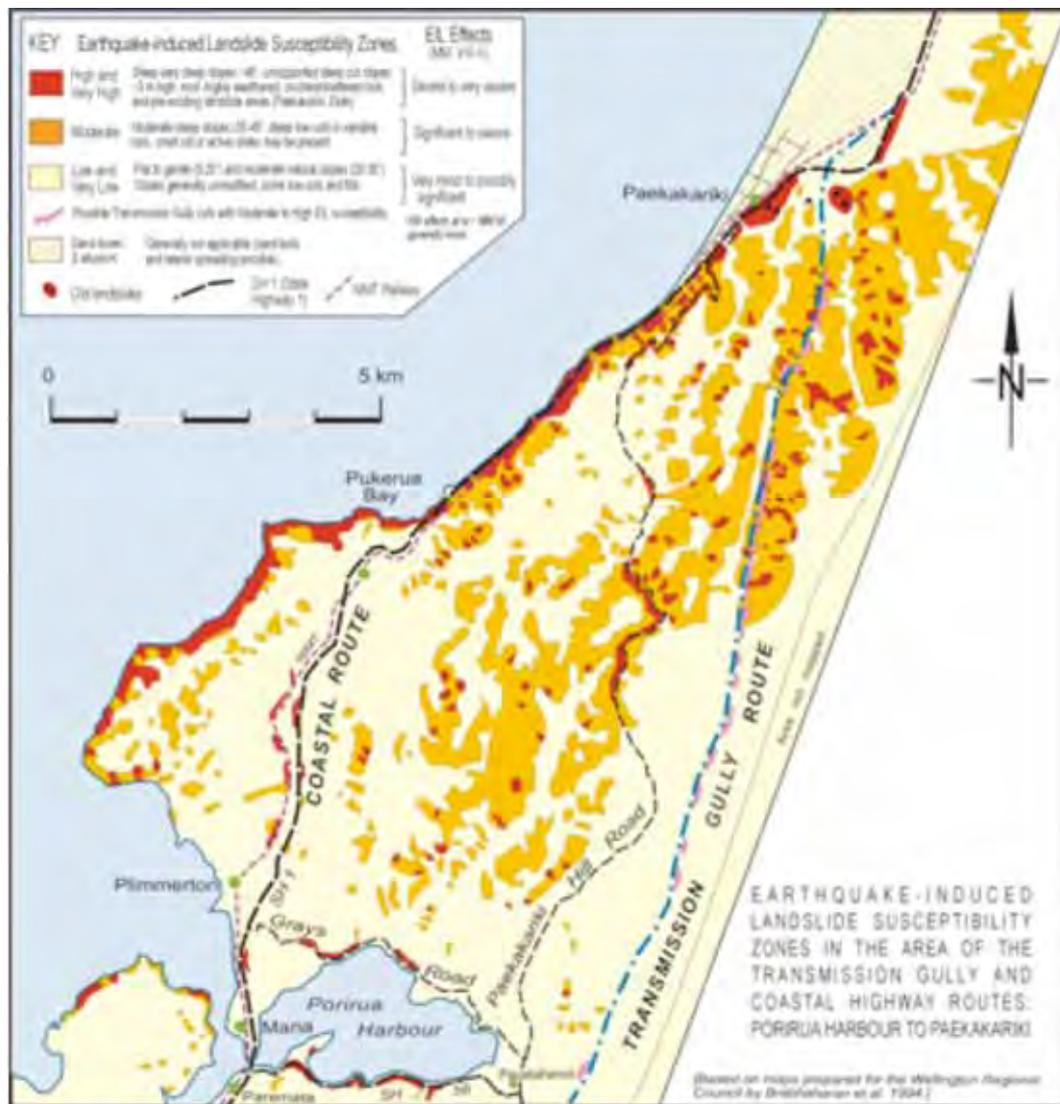
**Figure 5.** Map showing earthquake-induced landslide susceptibility in the area of the Coastal Highway and proposed Transmission Gully Motorway route from Porirua Harbour to Paekakariki area (after Brabhaharan et al. 1994; Wellington Regional Council, 1995).

Figure 5 shows that most of the area south of Pukerua Bay has low and very low EIL susceptibility, with only small areas of high susceptibility (red) on the Coastal Route north and south of Plimmerton.

The northern sections of both the coastal highway and the Transmission Gully Motorway routes from Pukerua Bay north have notably higher earthquake-induced landslide susceptibility (Figure 5). The steep coastal slope from Pukerua Bay and Paekakariki on the Coastal Route has mainly high to very high susceptibility, with only short sections rated as moderate. By contrast, the natural slopes along the

On almost all the steeper slopes ( $>35^\circ$ ) of the coastal cliff from Pukerua Bay to Paekakariki, and above the former quarry areas landslide susceptibility is rated as high to very high (Figure 5). Unsupported steep cuts for the NIMT railway and SH 1 at the toe of the slope contribute to this rating, making the overall slope more vulnerable to failure in strong earthquake shaking of MM9 and MM10. Shaking of this intensity could trigger moderate to large landslides from the top of the slope in several places along the Paekakariki coast. The possible locations of these landslides are shown in Figure 4. Volume estimates for such failures range from about 20,000 to 450,000 m<sup>3</sup>, and even 1 million m<sup>3</sup> or greater at one location (Hancox et al. 2005). They include several areas above or adjacent to historical slope failures (Figures 6 and 7), and areas of oversteepened ( $>60^\circ$ ) rock slopes above former quarry sites at Paekakariki (Figure 8).

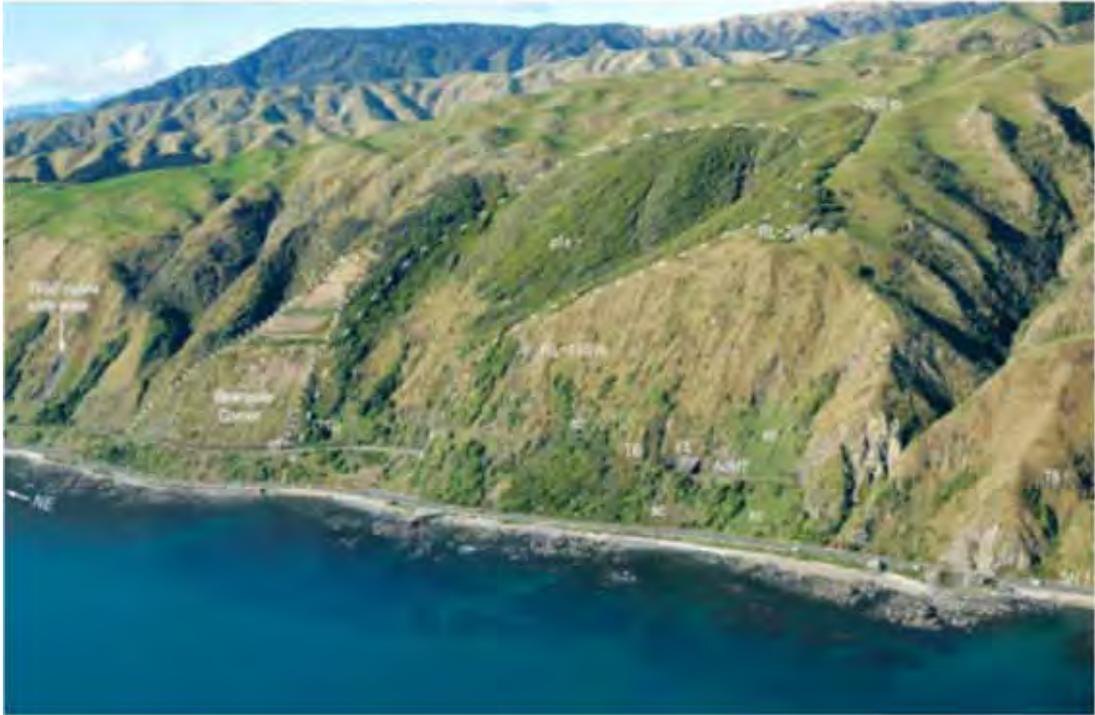
**Figure 6.** Aerial photo of the coastal slope at Beanpole Corner, where extensive stabilisation work was completed in 1990. Also shown are protective debris fences (*df*), rock shelter (*rs*) at tunnel portal, 1980 debris slide scar, steep, and a possible prehistoric landslide (*pls*, note displaced rock platform at coast and gravel beach), and scree (*sc*) deposits along the base of the slope [STOPS 1 and 2].

2]. Most of these failures were relatively small rock and scree falls which occurred during or after heavy rainfall. However, some slope failures have also occurred during dry weather, without any triggering event or failure history. The rock and debris fall on 19 November 1980 which derailed a south-bound train (see Figures 4 and 6) is one example of such an event.

Following several periods of heavy rainfall in 1979 a large slumped area developed 120 m up the slope (Inset A Figure 4, and Figure 6). After extensive site investigations and ongoing concern about landslide risk to the railway and SH 1 at this site, the slope was stabilised in 1990 by removal of 31,000 m<sup>3</sup> of material from the head of the slide (Saul 1992). The upper slopes have been stable since those works were completed, and although minor surface ravelling failures of loose debris have continued on the lower slopes, this material has been effectively contained behind the debris fence. However, because of the poor rock condition at this site and its long history of instability, there are still concerns about the long term stability of the Beanpole Corner slope, especially during strong earthquake shaking.

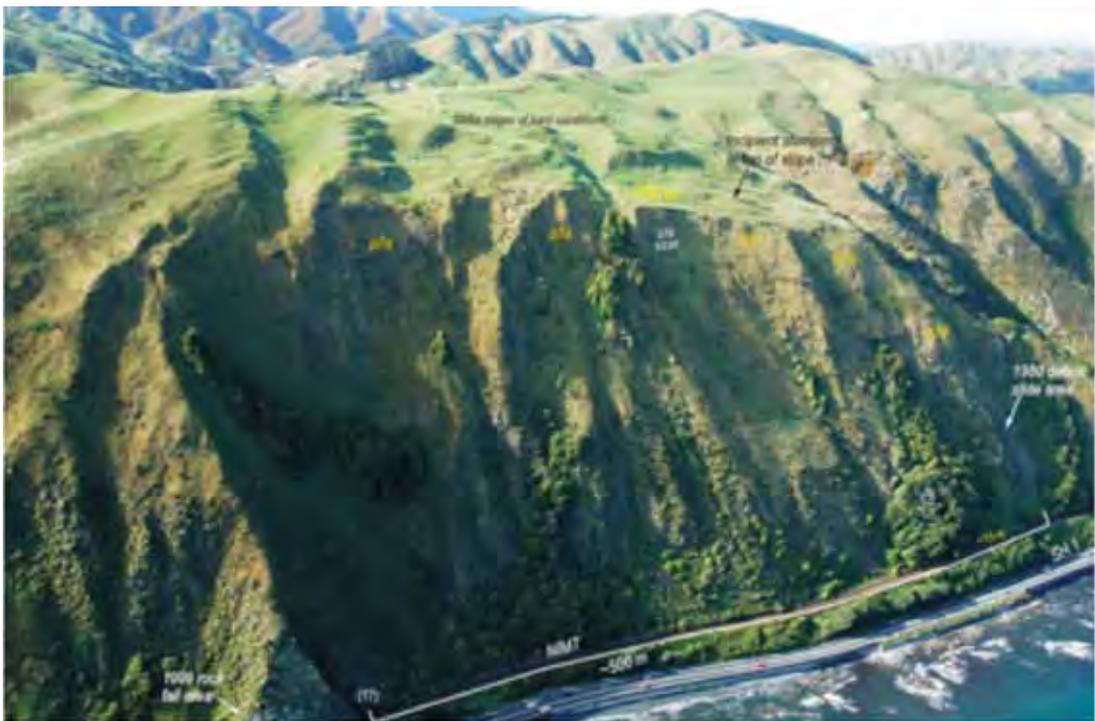
**Figure 7.** Aerial view of coastal slope south of Tunnel 7 (*T7*) showing old landslide scars (*ols*), incipient slumping at the top of the slope, and areas where large landslides could occur (*pfa*) in the future, particularly during a large (MM9-MM10) earthquake on the Wellington Fault. The site of a 1999 rock fall from the northern portal of Tunnel 7 is also shown [STOP 2].

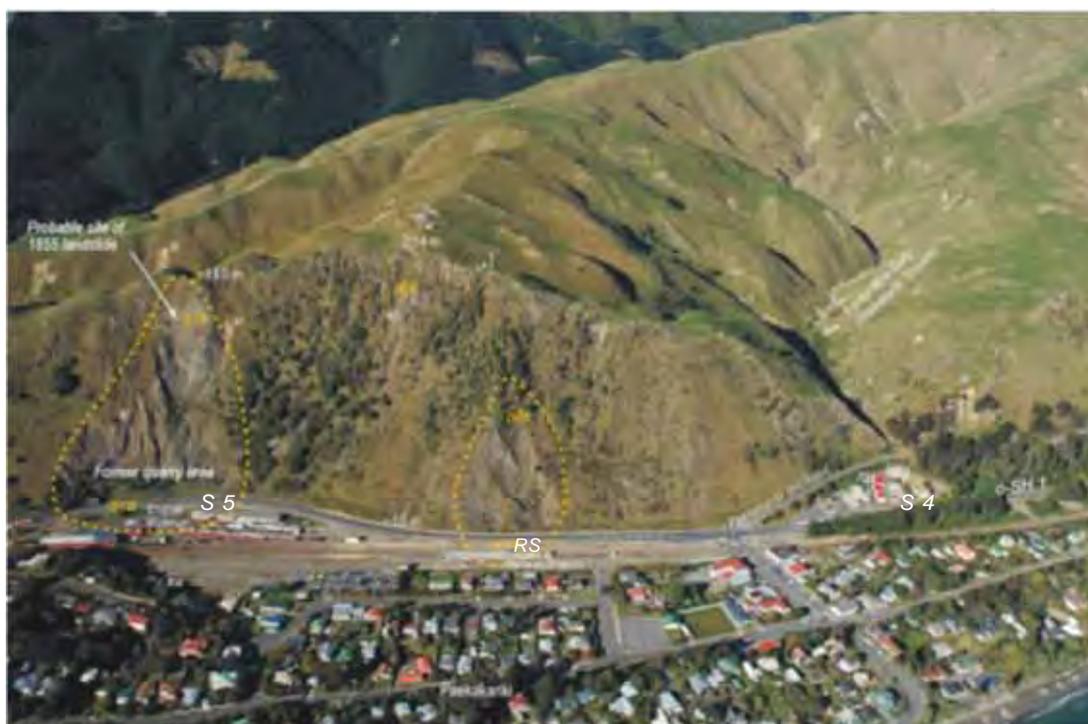
**Figure 8.** Aerial view of the site of 1855 landslide and former quarry at Paekakariki, and possible large future EIL failure areas (*pfa*) and debris runout areas (*dra*) near the Railway Station [STOP 5]. Also shown are soil slides (*sl*) and erosion gullies (*g*) in the Fly-by-Wire Gully, the motel (*m*) that was inundated by debris flood gravel, and the SH 1 culvert (*c*) blocked by gravel during storms in 2003, 2004, and 2005 [STOP 4 - see Figures 10 and 13 also]

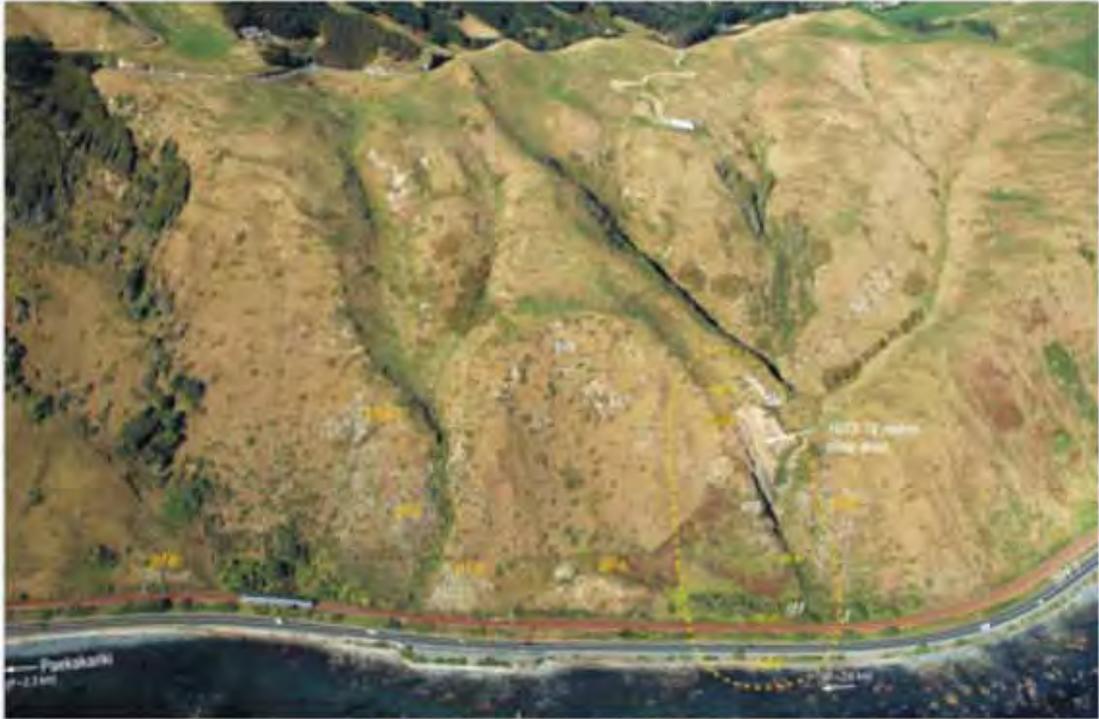
**Figure 9.** Aerial photo of the gully 500 m north of Tunnel 7 (see Figure 4) where debris flood deposits (*df*) caused problems for the railway from 1973 to 1981 (lower right). This material was derived from debris slides of weathered crushed rock (associated with major fault in gully) on the spur end. Note slumping (*slu*) above slide scar, and also in old scree along top of railway cut (*s*) - below older landslide area (*ols*). These and other potential EIL slope failure areas (*pfa*) are indicated.

Debris inundations (debris flood gravel deposits – see Appendix-2) have also affected the railway periodically. The gully 500 m north of tunnel No 7 is one area that was affected several times by debris flood deposits in the last 40 years, following a series of slope failures from a steep spur of crushed and weathered rock near the mouth of the gully (Figures 4 and 9). Although this area has not been very active since 1981, and is now covered with vegetation, the scar area is unstable, with a large incipiently slumped area above it (Figure 9). Other debris flood deposits have occurred in gullies near Beanpole corner in the 1970s and 1980s (Hancox 1981a, 1982b).

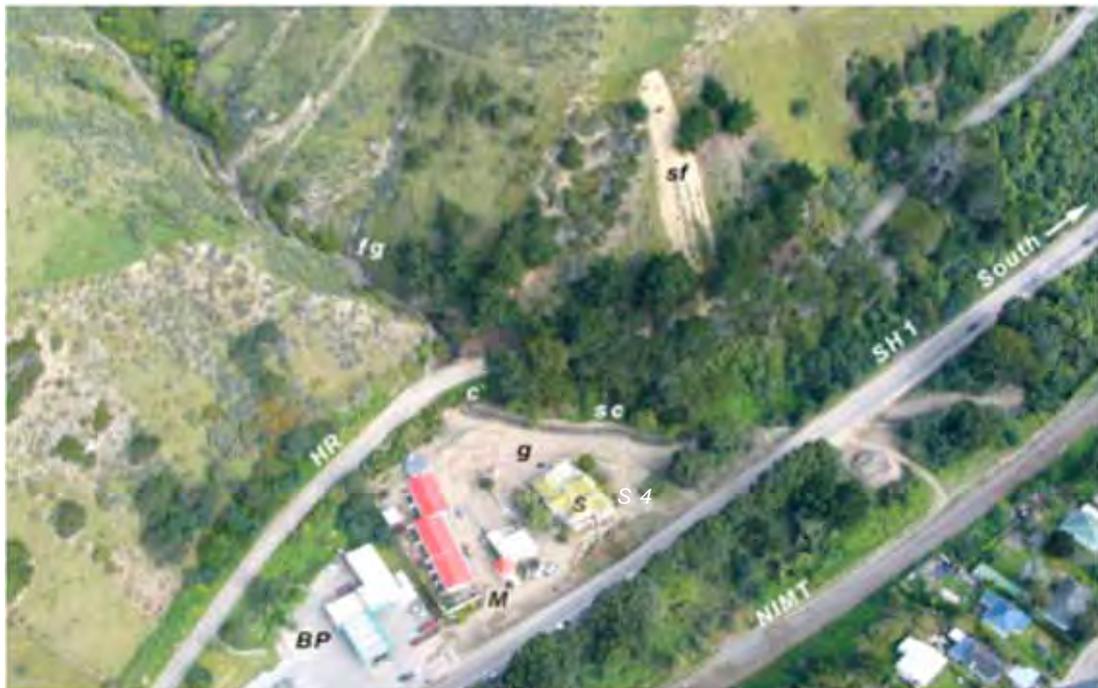
**Figure 10.** Aerial photo showing the gravel (*g*) from the Fly-by-Wire gully (*fg*) deposited around the Belvedere Motel (*M*) at the bottom of the Paekakariki Hill Road (*HR*), and across SH 1 during the rainstorm on 3 October 2003. A new stream channel (*sc*) was dug the day after the flood. The hill road was unaffected by the flood as the debris passed through the culvert (*c*) below the road. The BP Service Station (*BP*) was flooded but was largely unaffected by gravel inundation. A small soil flow slide (*sf*) spilled on to the hill road ~70 m south of the gully exit. [STOP 4 - see Figures 8 and 13 also]

More recently, flooding and debris flood gravels blocked SH 1 and stopped trains during the October 2003 Paekakariki floods (Figure 10). Other parts of the railway to the south of Paekakariki were also affected by gravel inundations during that event, but no significant rock falls were reported (Hancox 2003).

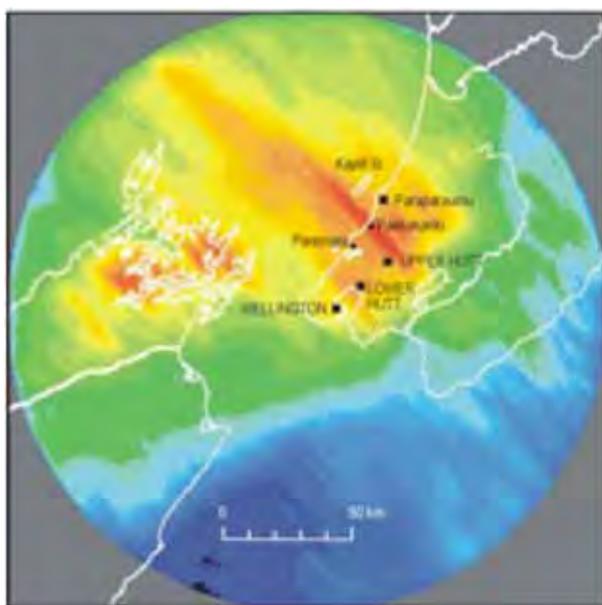
**Figure 11.** Radar-derived rainfall accumulation image for Friday 3 October 2003, showing total rainfall over the Wellington region for the period 6:45 am to 10:00 pm. Red is the heaviest rain and blue is the lightest. The band of heaviest rainfall coincides with the severe landsliding and flood damage observed in the Paekakariki area (*Image from MetService*)

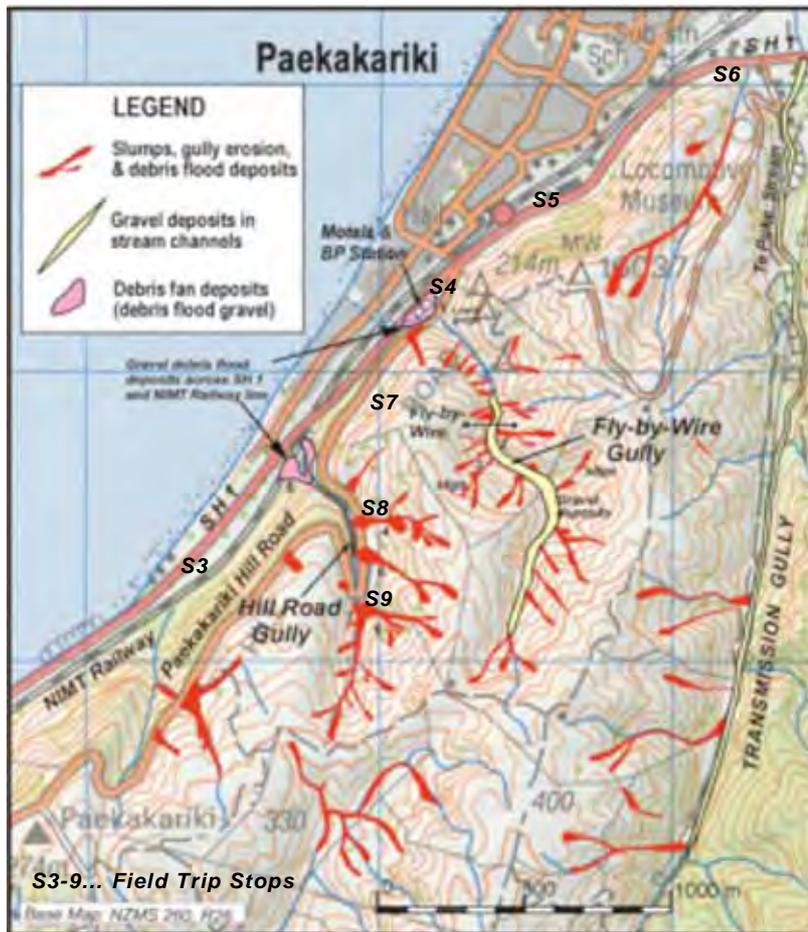
**Figure 12.** Map showing landslides, erosion gullies, and debris flood deposits resulting from the October 2003 Paekakariki flood. The main areas affected were the Fly-by-Wire gully and Hill Road gullies. Gravel from the former caused damage to a Historic Building and motel located on the debris fan at the bottom of the gully. Sites 4–7 were the most damaged parts of the hill road were [STOPS 8 & 9]. The total cost for road repairs was about \$500,000, and the road was not reopened until early November 2003. A similar event in February 2004, prompted construction of debris fences to control gravel deposits. Removal of gravel deposited at the SH 1 culvert in the two events cost around \$750,000.

The Fly-by-Wire and Hill Road gullies were severely damaged by numerous shallow slumps and deep erosion gullies (Figures 12 and 14). Geomorphic evidence suggests that the flood was a very rare local event with a return period of more than 100 years, or possibly several hundred years. A large amount of soil and gravel from steep slopes and gullies was transported down the stream and deposited on the debris fan around the motel buildings and across SH 1. Gravel from these gullies and deposited in stream channels has continued to be transported downstream during severe rainstorms in February 2004, January 2005, and August 2006.

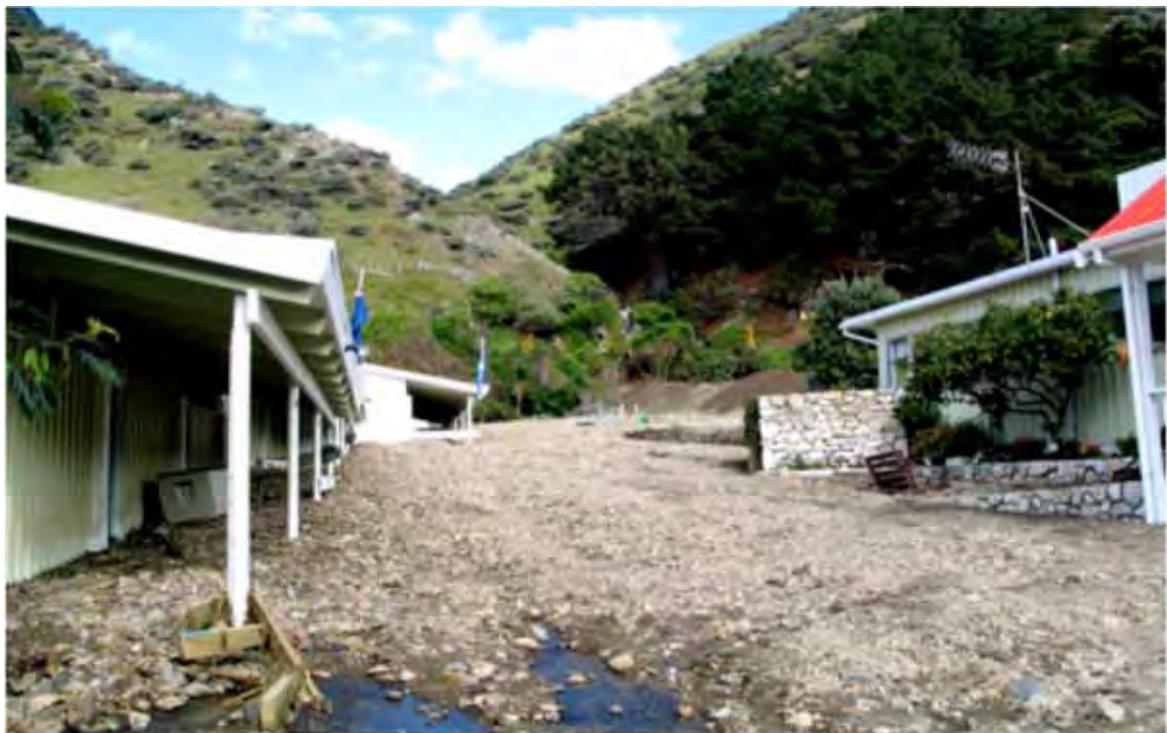
**Figure 13.** At the bottom of the Paekakariki Hill Road debris flood gravel from the Fly-by-Wire Gully was deposited slowly around the Belvedere Motel, buried cars and infilled a swimming pool. However, the gravel did little damage to the buildings and was eventually removed. A gravel bund now protects the site, and the motel has since reopened, despite similar debris flood events in 2004 and 2005 [STOP 4].

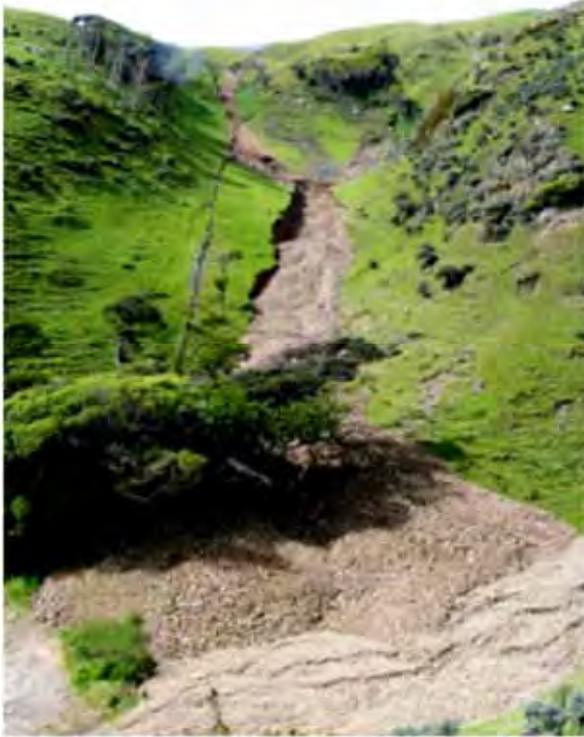
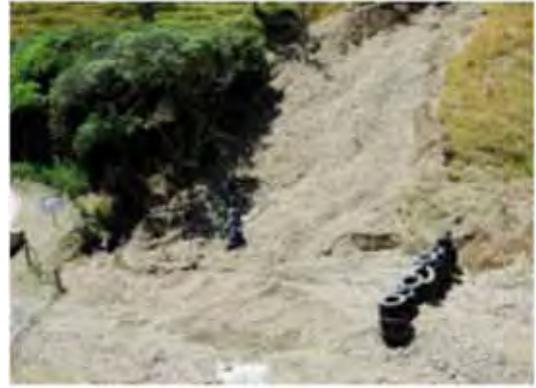
**Figure 14.** Typical erosion gully formed in the hills above Paekakariki during the October 2003 rainstorm [STOP 9]. Gravel blocked culverts and caused extensive washouts on Paekakariki Hill Road. There are no historical examples of such gullies, nor are they seen elsewhere in the area. It is inferred that the rainfall intensity that caused these gullies (in old periglacial gravels) has not occurred in the Paekakariki area since the clearance of native forest about 150 years ago. The top photo taken after the Jan 2005 rainstorm shows the effectiveness of simple debris fences.

Damage to the northern end of the Paekakariki Hill Road was the result of deposition of debris flood gravels, which blocked culverts in several places (Figure 14), and sent flood water surging down and over the edge of the road. Road cuts on the hill road were generally not affected, with only a few small rock and soil falls observed north of the summit. Gravel trapped behind undamaged fences and gates above the road suggests that this material accumulated slowly. Most of the silt and sand was carried away in flood water, which flowed over the road, washing out road edge fills and undermining the road in several places. This mechanism suggested that steel catch fences above the road and culvert entrances could be used to trap gravel during floods, while allowing water to pass through culverts (Hancox 2003).

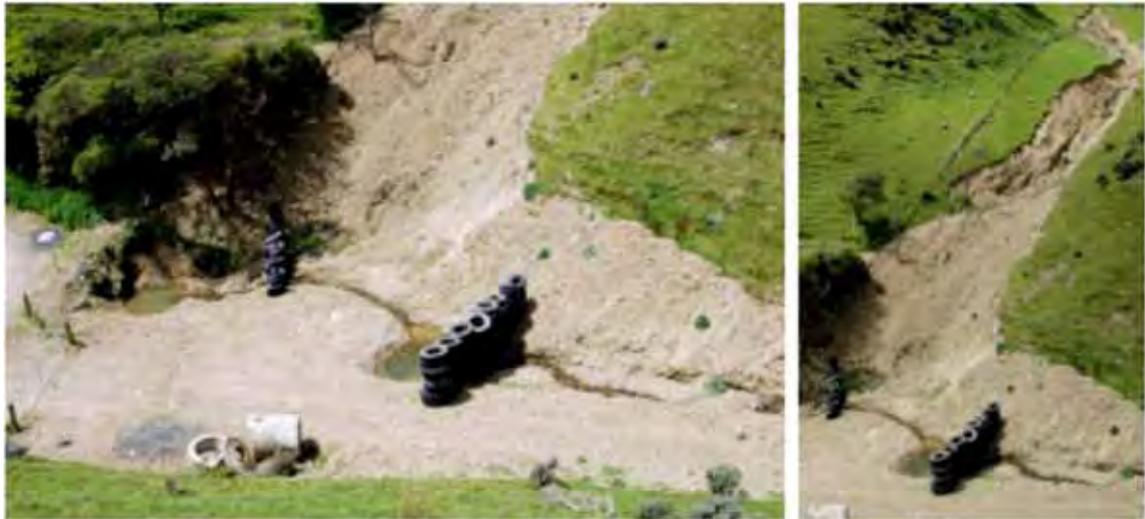
**Figure 15.** Debris fences (railway iron and old tyres) were recommended after severe rainstorms in October 2003 and February 2004. These fences were finally constructed in April 2004 (after the 2nd ‘100- year storm’ in 6 months) and prevented damage during a storm in January 2005 (see Figure 14).

After a second storm in February 2004 caused similar damage, simple debris fences (consisting of rails and old rubber tyres) were erected in three of the hill road gullies (Figure 15). These fences effectively trapped and retained gravel during further rainstorms in January 2005 and August 2006, and generally prevented further damage to the road, except at the northern gully (*Stop 8, Figure 12*) where gravel escaped under the fence (because of poor maintenance after the previous flood). Gravel again blocked the culvert at this location, sending flood water down the road and causing collapse of the road edge fill (*Stop 7, Figure 12*), and spilling debris on to and closing SH 1. The Paekakariki Hill Road was closed from 26 August to early November 2006 to allow the damage to be repaired (*Stops 7-9*).

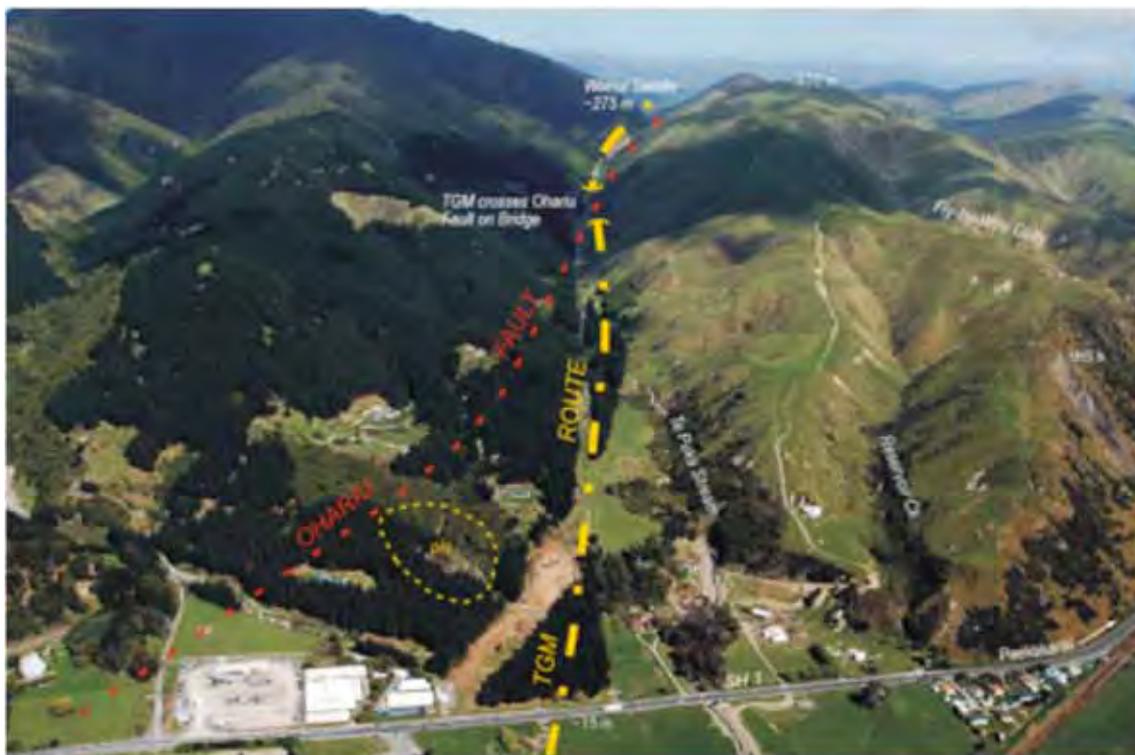
**Figure 16.** Aerial view looking south along proposed Transmission Gully Motorway Route, showing its position in relation to the Ohariu Fault (crossed by a bridge, or possibly on a cut and fill in the forested area on the east side of Te Puka Stream), and an inactive prehistoric landslide area (*pls*) [STOPS 10+]. Note that the slopes along the TGM route are lower and less steep than those along the coastal highway, with few landslide areas except for shallow soil slides (*sl*) formed in recent storms - during which culverts (*c*) under SH 1 were blocked by gravel [STOP 6].

Transmission Gully route in Te Puka and upper Horokiri streams have much lower EIL susceptibility—mainly rated as moderate, with only a few small areas of high susceptibility. This is consistent with the generally lower overall slope height, flatter average slope, and lack of deep seated landslides along the TGM route (Figures 16 and 17).

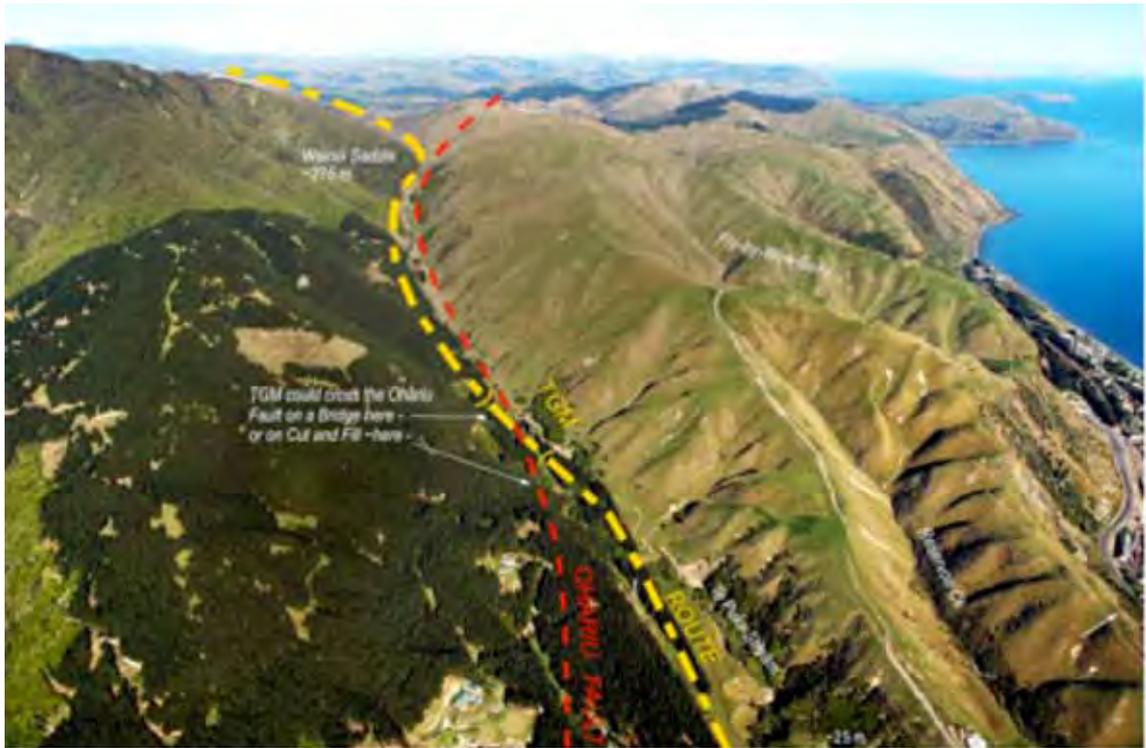
**Figure 17.** Closer view (looking south) of the northern section of the TGM Route up Te Puke Stream, showing its position in relation to the Ohariu Fault - which could be crossed on a bridge, or on a cut and fill. This view shows the Field Trip route up Te Puke Stream (on 4WD track lower right) [STOPS 10+].

In the upper Te Puka Stream southeast of Paekakariki, the Ohariu Fault lies on the western side of the Transmission Gully Motorway route (Figure 2; Figure 17). To allow for the possibility of future fault movement, the proposed motorway could cross the fault on a bridge structure on the northern side of Wainui Saddle. This would require detailed seismic design consideration to reflect the close proximity of the Ohariu Fault, and to determine the exact position of the fault, and likely displacement values. However, although significant damage might occur, the possibility of catastrophic failure of such structures is considered to be low if modern design standards are applied (Beca 1996; Beca 2004; Ramsay 1997). Crossings of active faults on cuts and fills would probably be safer and less costly and may eventually be the preferred option.

However, the lower cuts that were proposed (most are less than 30 m high and a dozen or so are 30-50 m in height) in the 2004 cost estimate (Beca 2004) would have *low to moderate* susceptibility. During an MM9-10 earthquake small to moderate failures (1,000–20,000 m<sup>3</sup>) of natural or cut slopes are expected, depending on their height and support measures. Most of the areas where higher cuts might be required are located occur along Te Puka Stream section of the TMG route, north of Wainui Saddle. Some of these areas will be inspected during the Field Trip up Te Puka Stream [*Stops 10+*, see *Figure 17*].
