Geosciences 2013

Field Trip 2

Earthquake Engineering Geology: Port Hills and Christchurch City.

Guide authors: David Bell, Janet Brehaut and Maree Hemmingsen

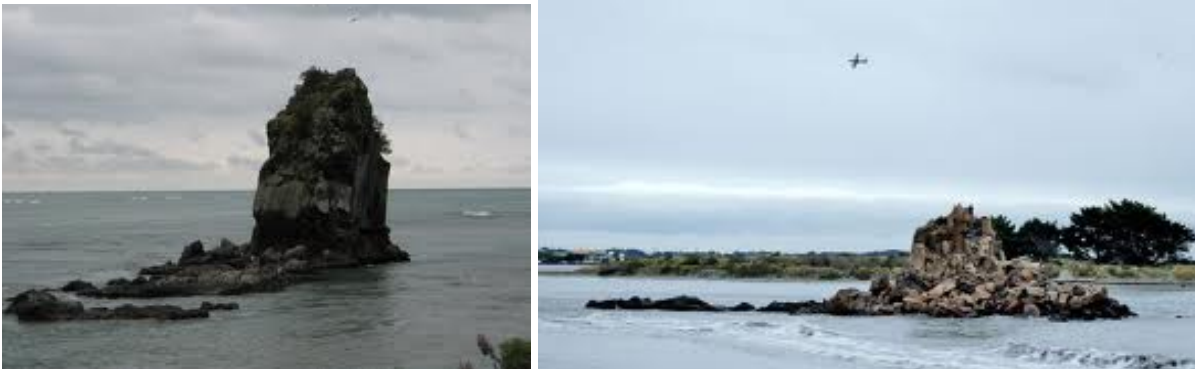
Figure 4 Shag Rock before (wikipedia.org)

and after (cbc.ca).

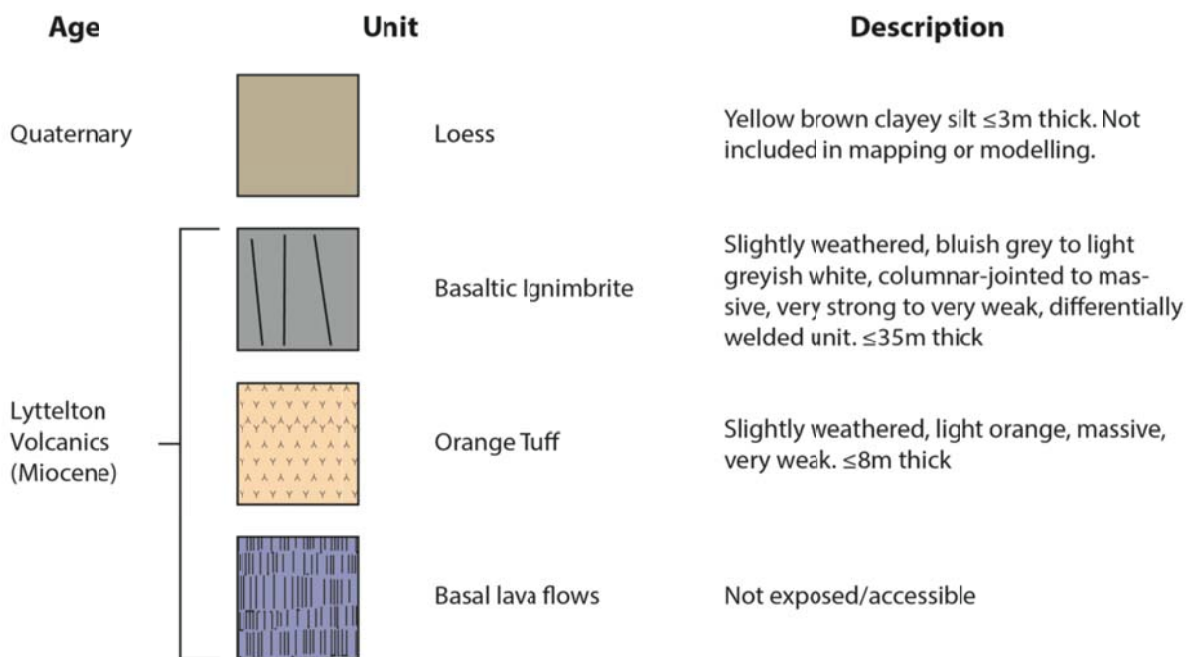
Figure 5 Simplified Redcliffs Stratigraphy

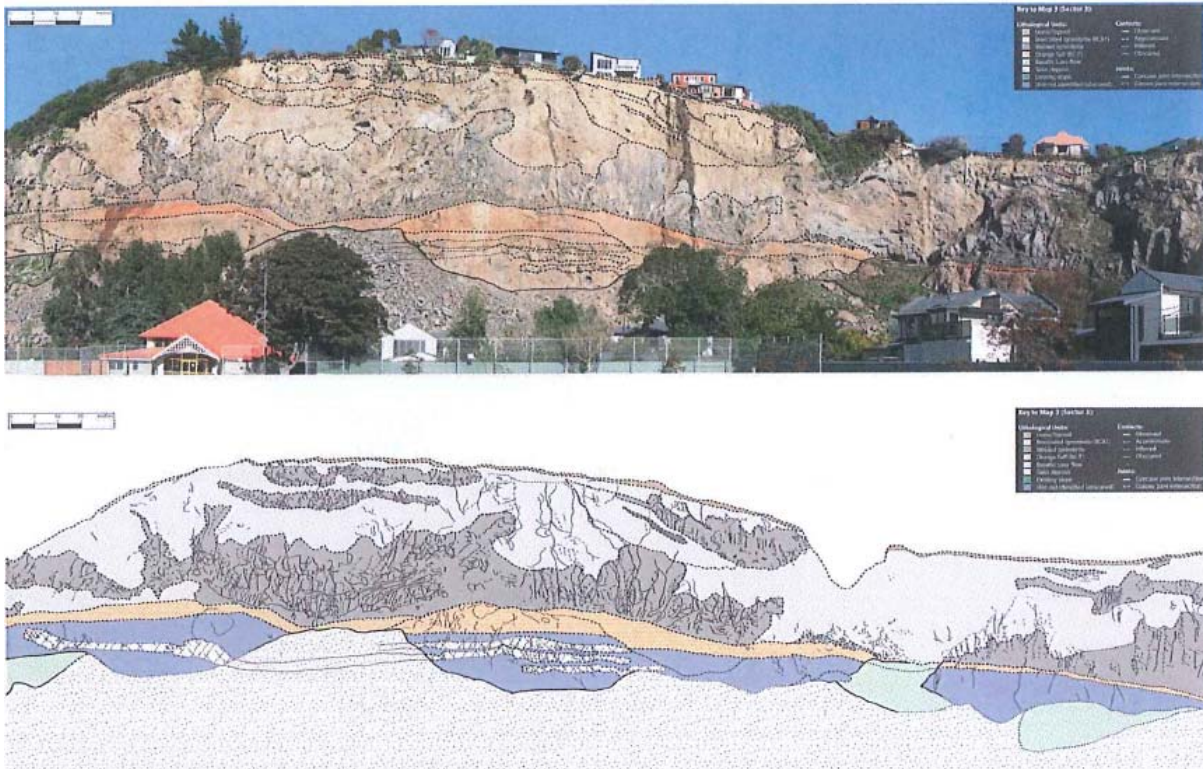
Figure 6 Sector 3 face log

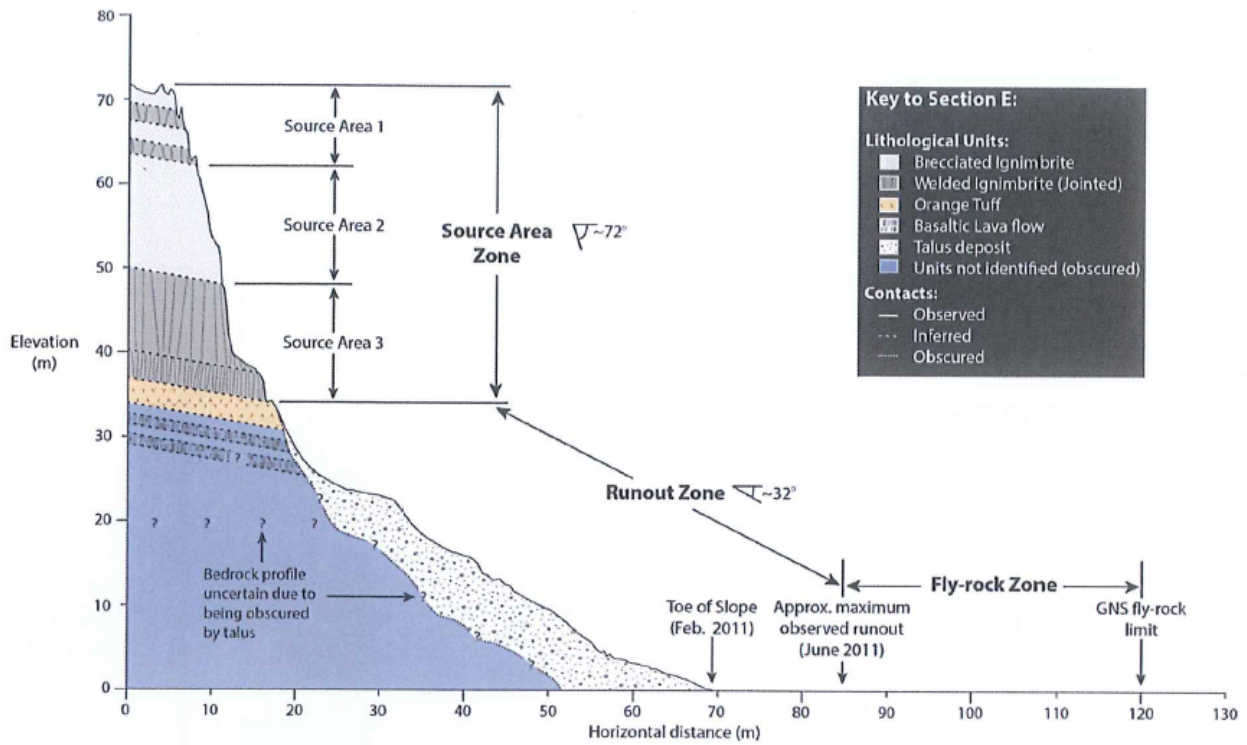
Figure 7 Cross section (of section E) – School Hall

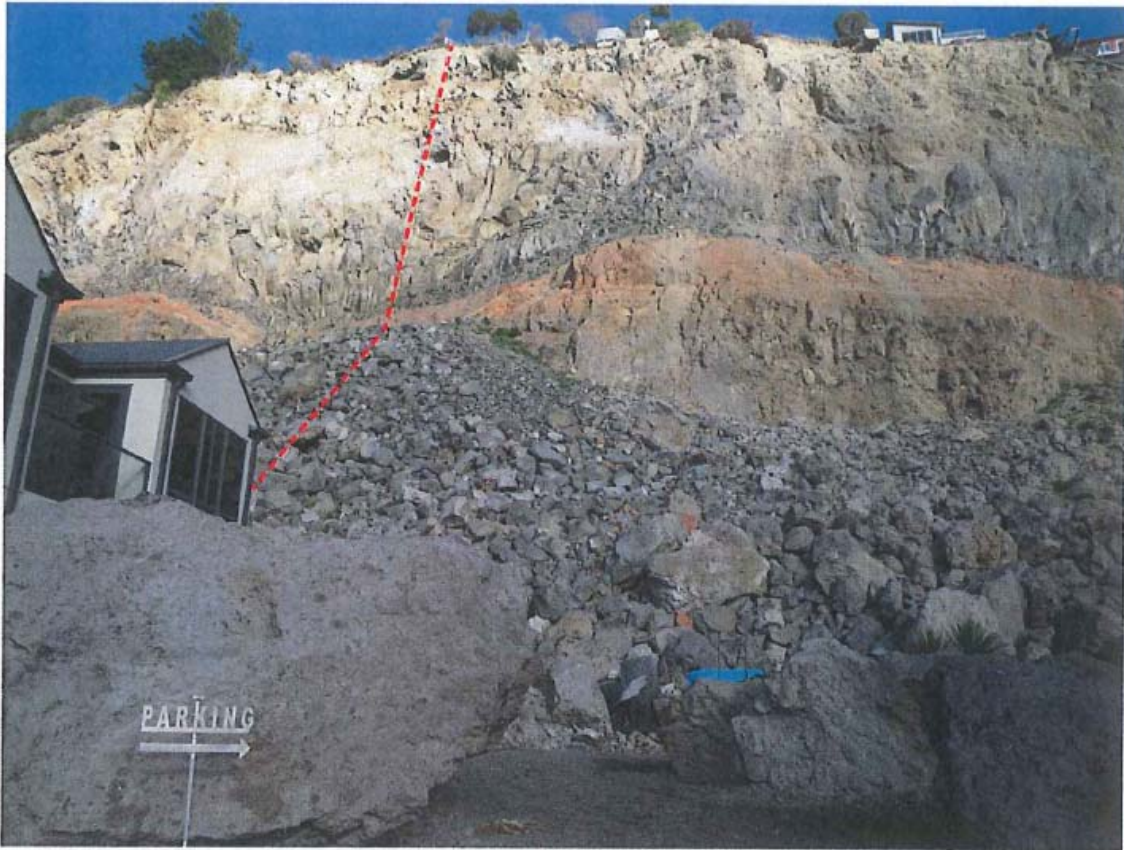
Figure 8 Photo showing runout adjacent to Section E

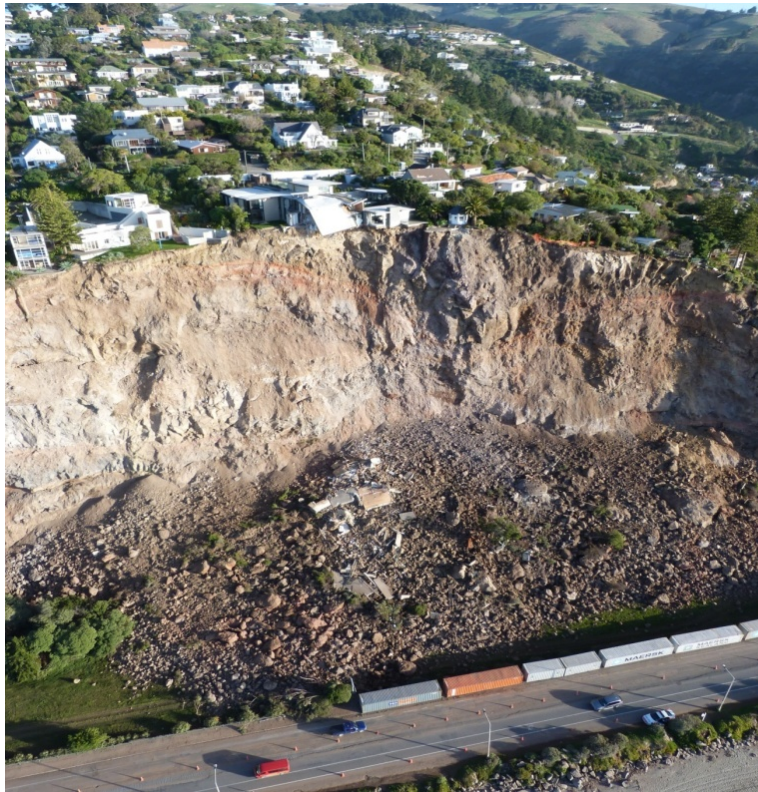
Figure 9 Cliff collapse at Clifton Hill following the 22 February and 13 June 2011 earthquakes - flown 14 June 2011. Note the partially collapsed house and use of ballasted shipping containers as temporary catch fences (Photo credit: Marlène Villeneuve/David Bell).

Rockfalls mostly occurred from the jointed lava flows, leading to tens of houses being impacted by falling rock in Redcliffs, Heathcote Valley, Lyttelton, Rapaki and Sumner. The mitigation measures in place (fences, benches and trees) were overwhelmed by the large number and volume of rocks, which came down off the hills. During the 22 February and 13 June earthquakes, large-scale cliff collapses occurred in Redcliffs and Sumner (south-east Christchurch suburbs). Up to 15 m of cliff failed along sub-vertical cooling fractures and through intact rock during each shaking event due to very high vertical and horizontal accelerations ($>1.0g$). This led to hundreds of houses being severely damaged, requiring evacuation, and ~100 houses unlikely to be reoccupied both at the cliff top and base. Power, water and sewage services were also severely damaged in the hill suburbs. Clifton Hill collapses threatened the seaward road linking Redcliffs and Sumner to Christchurch city, requiring the use of ballasted shipping containers to be used as a temporary catch fence (Figure 9).

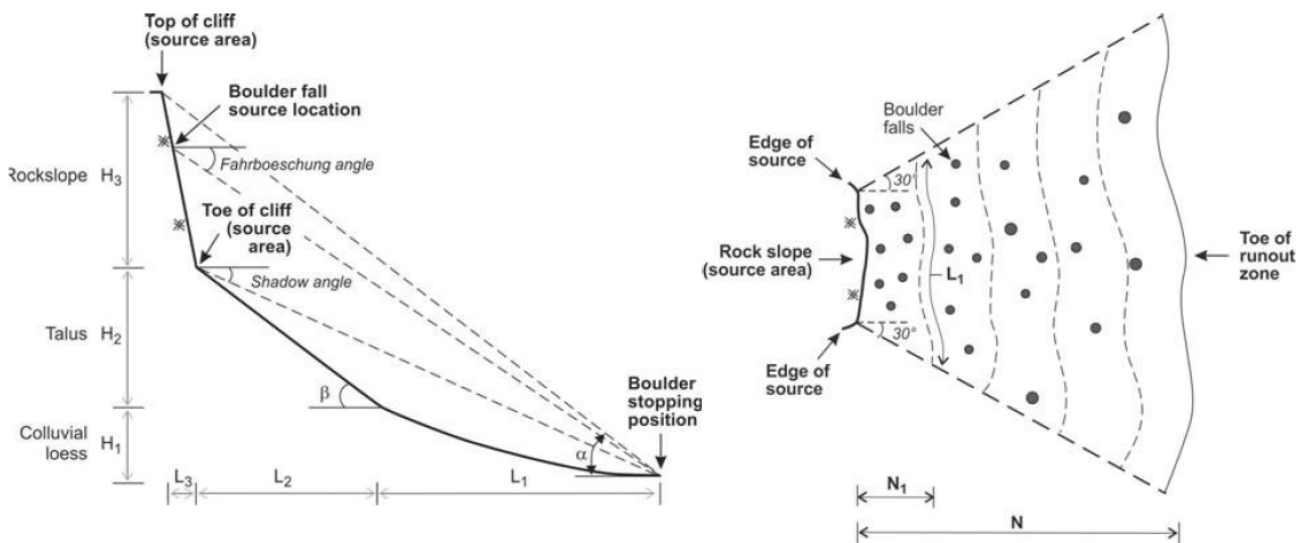
Figure 10 GNS runout distances

Since September 4th 2011 GNS Science and geotechnical teams have been mitigating rock fall hazards. To gain a further understanding of rock fall trajectories, including runout distances, zone of runout and influence of variables (i.e. slope, source, rock/block size and angularity), GNS Science has predicted a zone / window of potential runout, bordered at the source area by a 30° runout constraint (see figures 10 & 11).

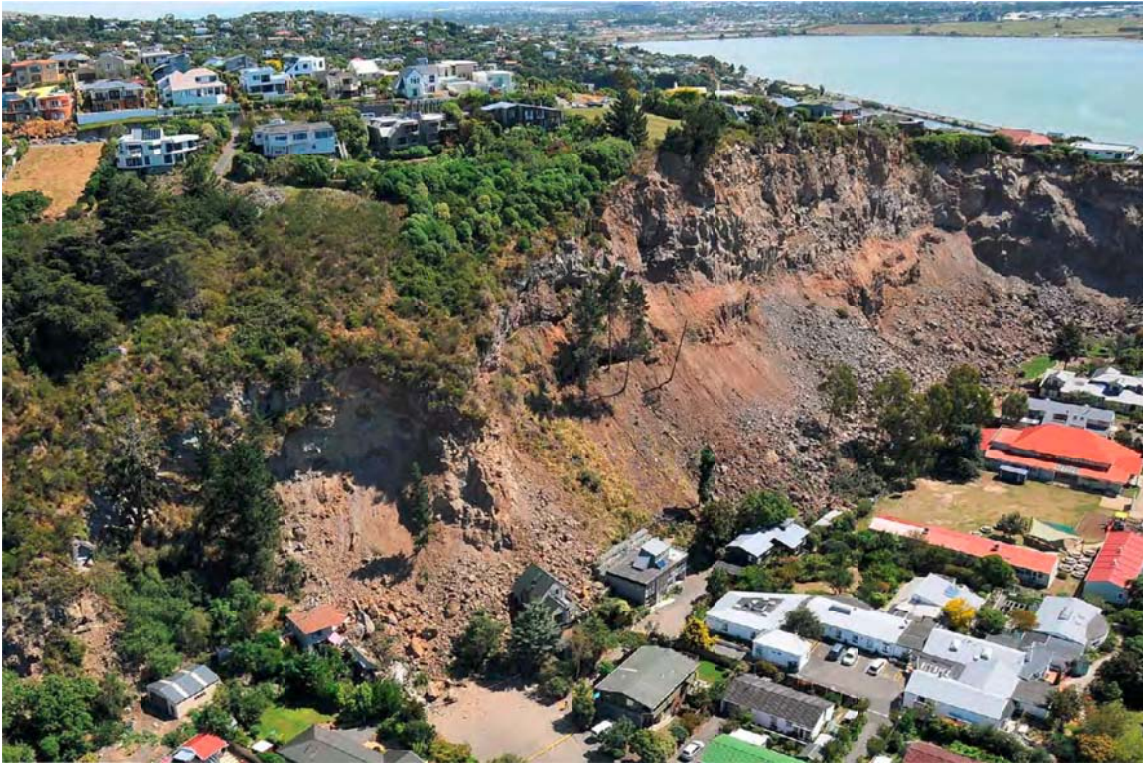
Figure 13 Redcliffs, Image from GNS

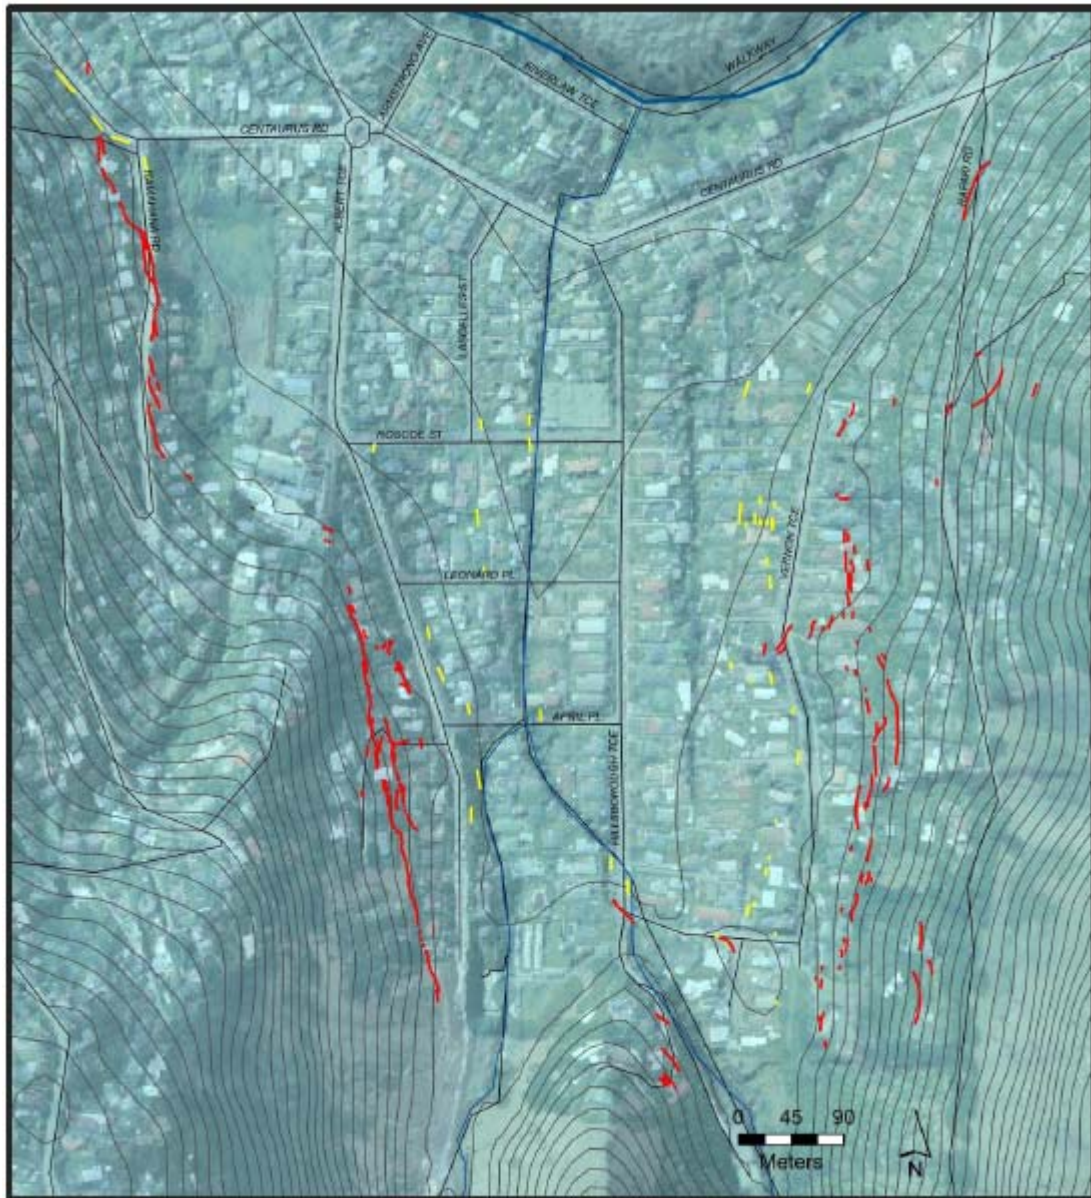
Figure 15 Areas of obvious compression in the Hillsborough Terrace valley. Compression features, usually parallel to fissure trace above, are shown in Yellow. (from Stephen-Brownie, 2012)

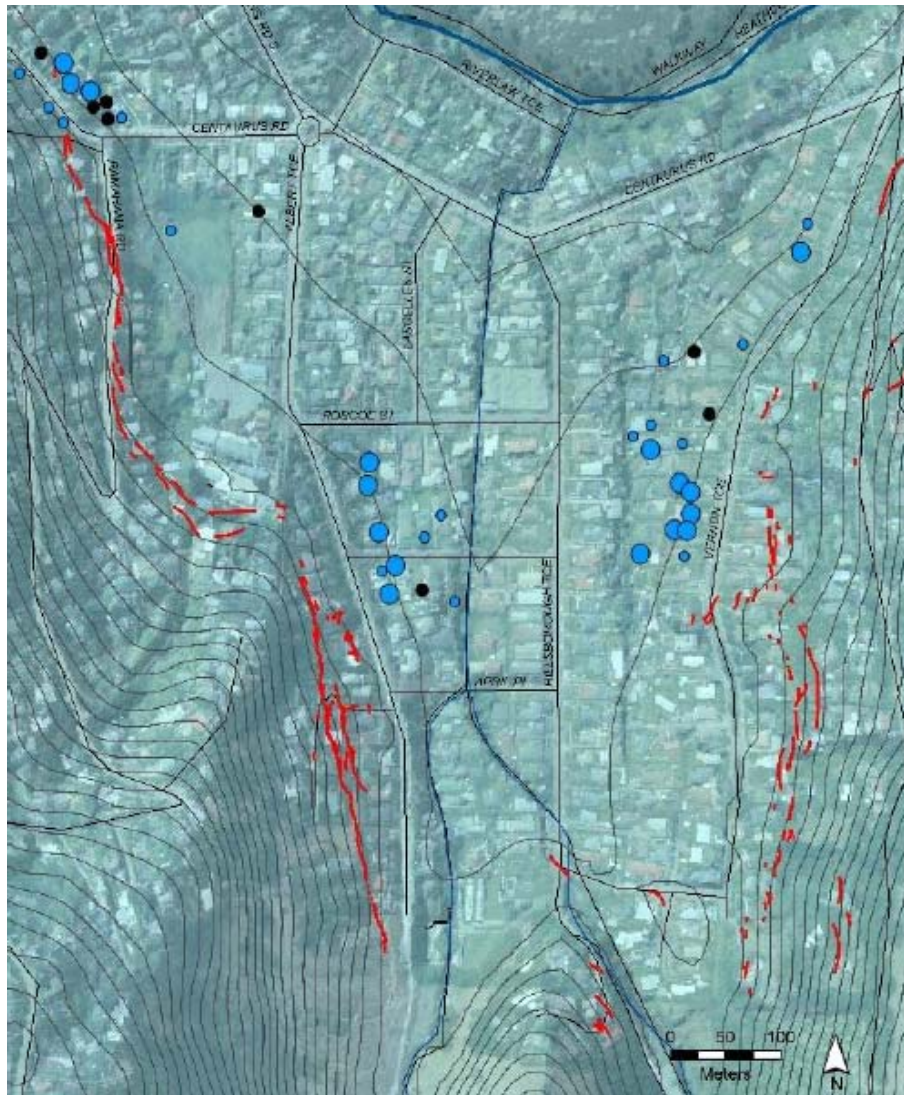
Figure 16 Map of known locations of springs, seepage and/or ponding issues in the Hillsborough Terrace valley area. Large blue dots show sites of flowing springs, small blue dots are areas of persistent seepage or boggy ground, and black dots show sites where ground water issues were reported but the extent is unknown by author (Stephen-Brownie, 2012). Red lines indicate the fissure trace. Spring data from H.Rutter (Aqualinc, 2012) and Stephen-Brownie's own observations. (from Stephen-Brownie, 2012).

One feature of fissuring has been the contemporaneous formation of new springs and seepages in some valley floors. The Hillsborough Valley region has at least two dozen new springs which do not appear to be greatly affected by season or rainfall. The springs are located in three main groups; one at the western fissure; another along the eastern side of Albert Terrace; and the third about half way down Vernon Terrace on the western side of the road (Figure 16)

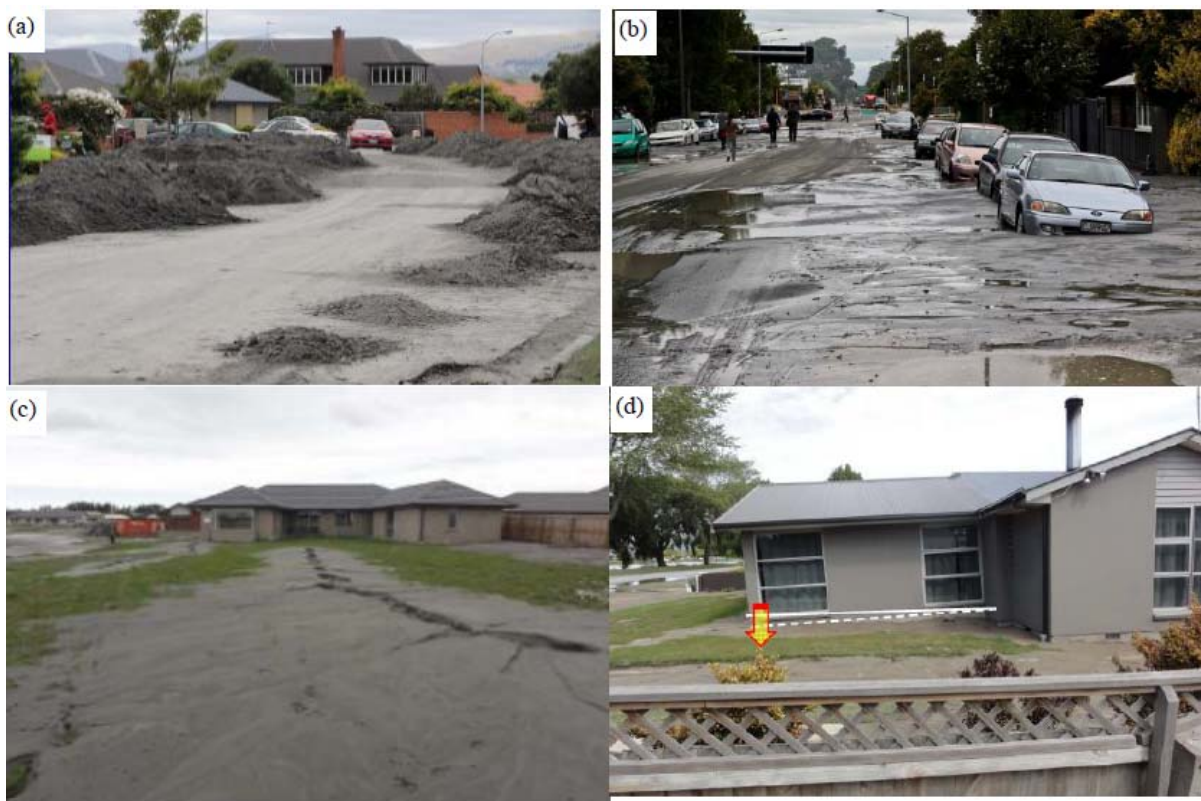
Figure 17 Typical manifestation of liquefaction in residential areas (Fig. 19 from Cubrinovski et al. 2011)

Nearly 15,000 residential homes and properties were severely damaged due to liquefaction and lateral spreading, and more than half of those beyond economical repair. About 5,000 properties will be abandoned due to the infeasibility of repair (NZ Govt., 2011 in Cubrinovski et al, 2011). Examples of the results of liquefaction in residential areas are presented in Figure 17

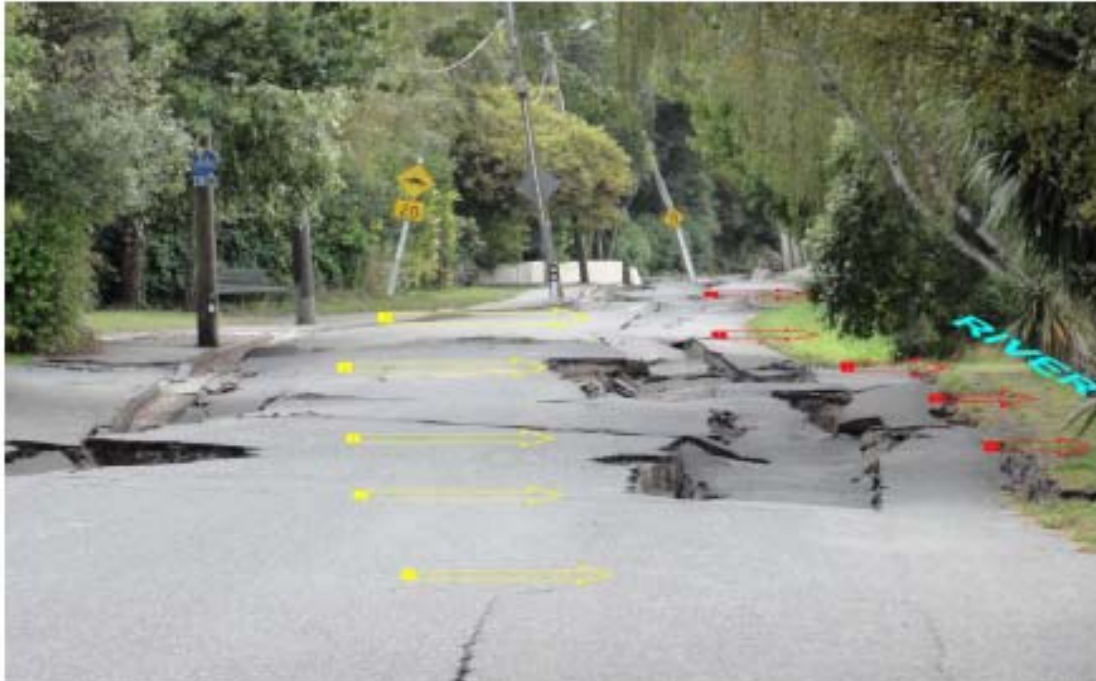
Figure 18 Lateral spreading toward the Avon Rivers (Fig 24 from Cubrinovski et al. 2011)

Along the Avon River lateral spreading, causing horizontal displacement at the river bank in the order of several tens of centimetres to more than 2 m (Figure 18). Ground cracks associated with lateral spreading extended as far as 100-200m from the river.

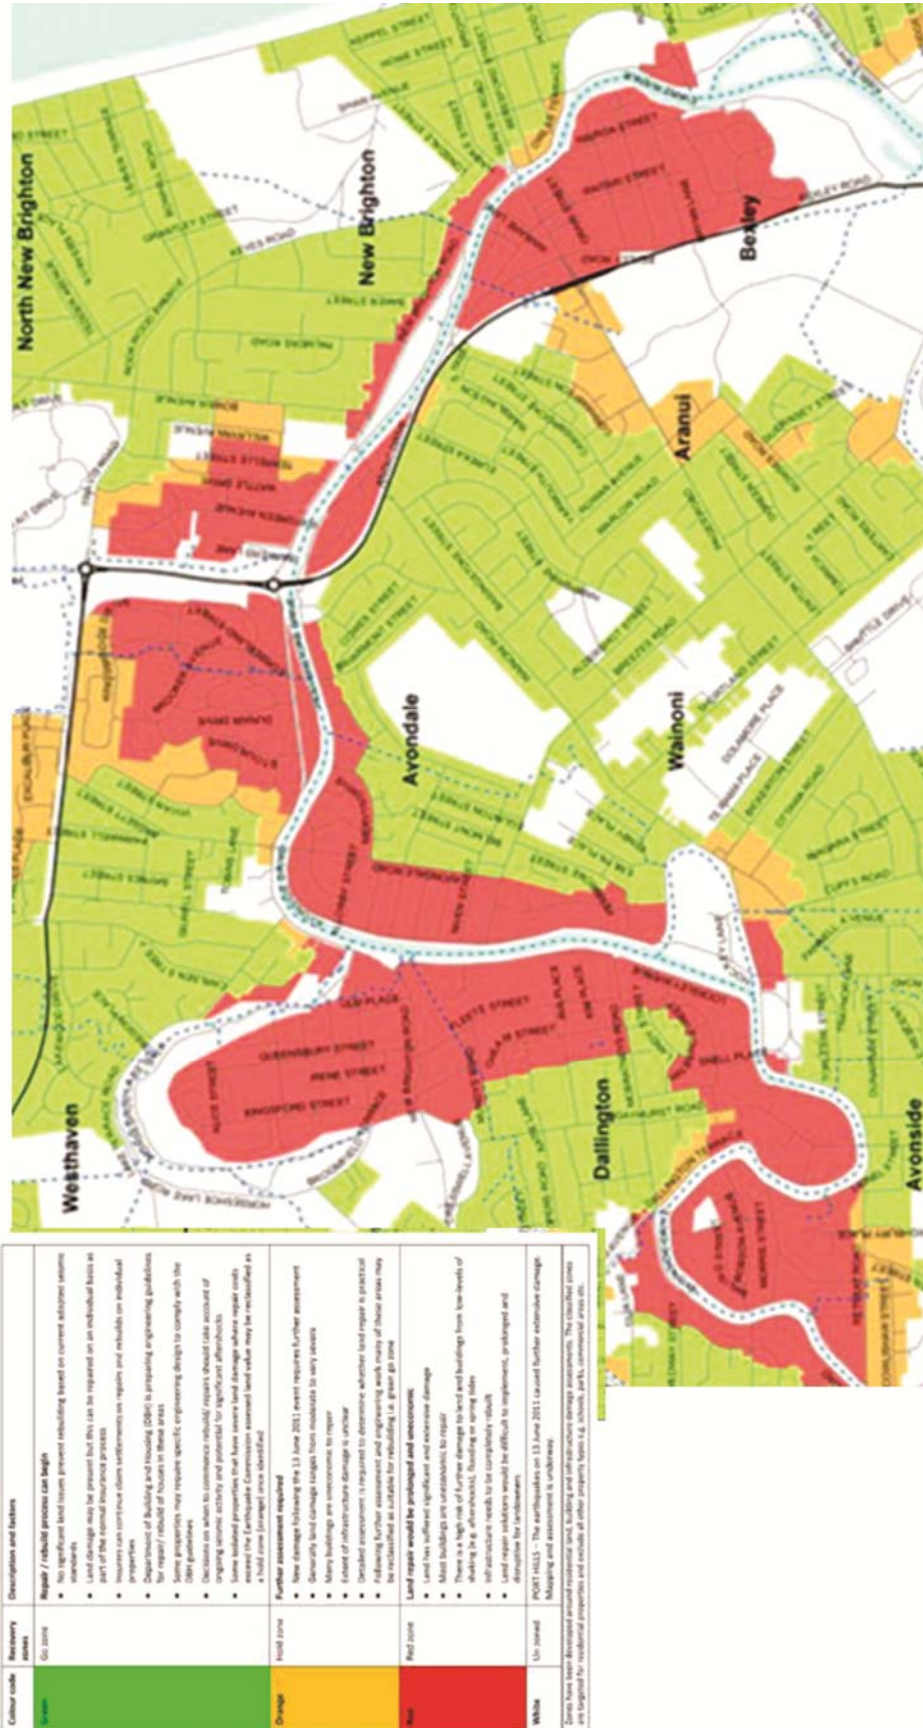
Canterbury land information zoning map (CERA)

Following the geotechnical testing, analysis of the future flooding and liquefaction hazards, and the property and lifeline damage, land within Christchurch was categorised into 4 zones:
